**APPENDIX D**  
**TASK FORCE GUARDIAN DETAILS**

# Lake Pontchartrain, LA and Vicinity Hurricane Protection Project

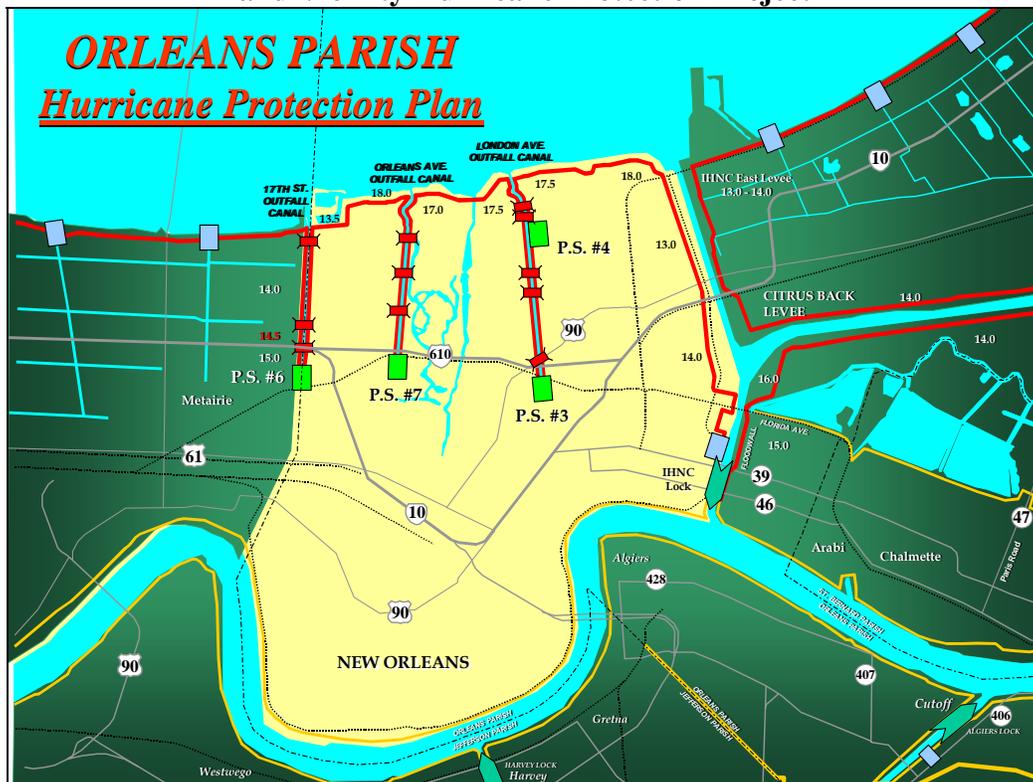
**Figure 2**  
**Map of the Eastern Half of the Orleans East Bank Portion of the Lake Pontchartrain, LA and Vicinity Hurricane Protection Project**

The Orleans East Bank portion of the Lake Pontchartrain, LA and Vicinity Hurricane Protection Project was damaged by Hurricane Katrina in late August 2005. The flood event produced storm surge levels at the levee along Lake Pontchartrain of approximate +17.0 ft NAVD 88. The height of the existing levees varied, but the levee crowns were generally at an elevation of 17.0 ft NAVD 88. The damage consisted of extensive breaches, scour, and erosion of the levees along the 17<sup>th</sup> Street Canal, London Avenue Canal, and the IHNC, as well as minor damage to the levees and floodwalls along Lake Pontchartrain (see Tables J-1 and J-2). In addition, there was extensive damage to the floodwalls in these same segments of the hurricane protection system along the Orleans Lakefront and Orleans Avenue Canal.

Structural repairs to the project would consist of restoring the levee to its pre-flood alignment by replacing each damaged section of floodwall and levee embankment to its authorized project height (Figure 2). The repairs would be broken into two major components, Phase I and Phase II Floodwall Repairs. Phase I Floodwall Repairs would consist of temporary hurricane protection at the 17<sup>th</sup> Street Canal breach and the two London Avenue breaches along their same general alignment. The Phase I Floodwall Repairs would employ steel sheet piling up to an elevation of 14 ft NAVD 88.

Phase II Floodwall Repairs involve construction to the authorized project height, returning the project to its pre-storm height plus overbuild. The Phase II Floodwall Repairs at the three breaches would consist of constructing pile founded reinforced concrete T-wall monoliths on the same alignment as the original I-walls. The 600-foot length of I-wall that rotated on the east side of London Avenue south of the Robert E. Lee Bridge would also be replaced with pile-founded T-wall monoliths. Due to the changed foundation conditions, a T-wall design is a more appropriate application in this area. The 1,400 feet of damaged I-wall floodwall along IHNC West Levee would be replaced with a buttressed I-wall section along the same alignment (also as a result of changed foundation conditions). Overtopping, scour, and erosion along the IHNC West Levee and Lakefront Levee and floodwall would be backfilled with compacted clay material.

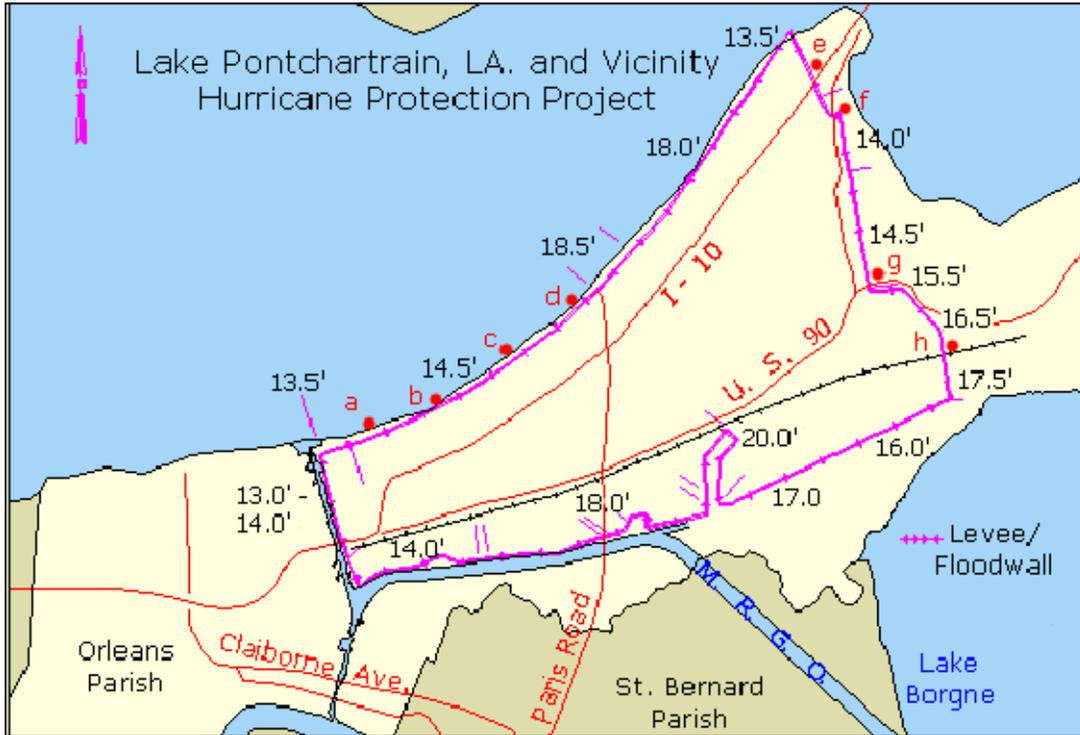
**Figure 3  
Orleans East Hurricane Protection**

The New Orleans East portion of the Lake Pontchartrain, LA and Vicinity Hurricane Protection Project was damaged by Hurricane Katrina in late August 2005. The flood event produced storm surge levels that overtopped the existing protection along the Mississippi River Gulf Outlet (MRGO) and Gulf Intracoastal Waterway (GIWW). Wave action also contributed to the failure. Major breaching occurred along this stretch of levee, resulting in the levee's erosion and scouring. In addition, there was damage to the railroad closure structure located in the South Point to GIWW levee segment. The remainder of the levee protection system received less severe damage, primarily scouring on the land-side of floodwalls, localized scouring of earthen levees, and scouring of the tie-in at each closure structure.

Structural repairs to the project have been broken into three major components. The first involves reconstruction of the portion of the hurricane protection system along the GIWW/MRGO (approximately 33,000 feet of earthen levee and floodwalls) with the same general alignment as its original construction (Figure 3). Levee and floodwalls elevations would match authorized heights, returning the project to its previously constructed height. Approximately 700,000 yards of semi-compacted (475,000 cy) and un-compacted (205,000 cy) impervious materials will be needed to rebuild the levee along the MRGO. The cross section used would be the same used during the most recent levee construction contract along this reach. The second repair would be to replace the I-wall segment at Pump Station 15, which ties it to its adjacent levee segments. The third repair would be to construct a sheetpile floodwall along the same alignment as the original sheetpile segments. Approximately 125 acres of turf would need to be established as part of the repairs.

The remaining work to be performed will be awarded as six additional contracts and consists primarily of repairing scoured areas throughout the remainder of the hurricane protection system, including repair of the damaged closure structures. These repairs would require the placement of approximately 64,860 sf of sheetpiling, 39,000 cy of clay, 54,650 tons of riprap and 15,500 tons of rock.

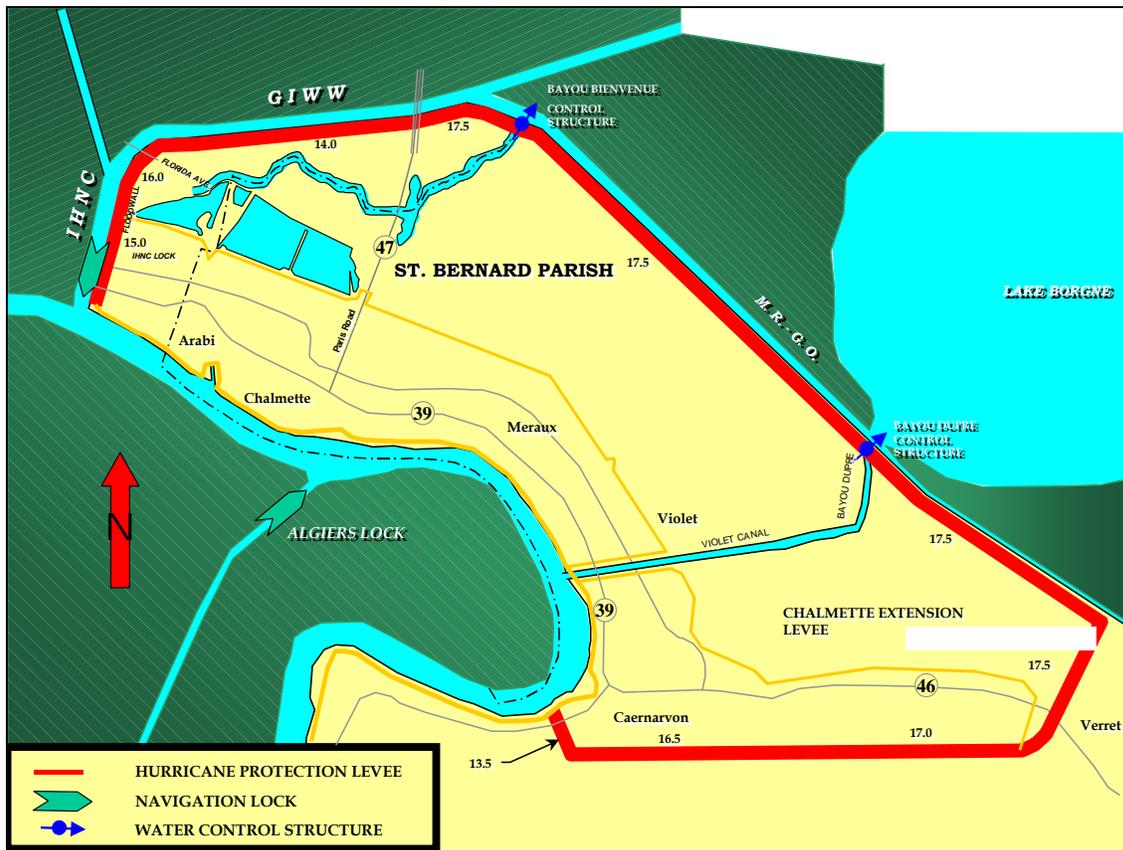
**Figure 4  
Chalmette Area Plan**

The Chalmette Area portion of the Lake Pontchartrain, LA and Vicinity Hurricane Protection Project was damaged by Hurricane Katrina in late August 2005. The flood event produced storm surge levels at the levee along the MRGO at approximately elevation 19.0 NGVD (El.19.0). Numerous breaches, scour, and severe erosion occurred along this stretch of levee as a result of overtopping. In addition, there was damage to the two control structures located in the levee segment along the MRGO.

The repairs will consist of six major components. The first is to reconstruct the hurricane protection levee along the MRGO with the same general alignment and design as the original construction. Approximately 1.6 million cubic yards of impervious materials will be needed to construct the levee. The elevations of the levee will match the authorized project height (generally 17.5 ft NAVD 88), returning the project to its previous lift height plus overbuild. The sheetpile floodwall sections will be replaced with levee embankment. The cross section used will be that used during the most recent levee construction contract along this reach. The second component will be to repair the two control structures including the I-wall floodwalls that tie these control structures into its adjacent levee segments. The third component will be to replace the damaged and failed floodwalls along the IHNC with new T-Walls. The fourth component will be to repair the foundation by backfilling each of the four road closure structures that were overtopped. The fifth component will be to repair the Creedmore Drainage Structure by clearing the debris in the gatewell and replacing the sluice gate hoists and stems. The sixth component would be to repair the minor scour on the crown and backside of the levee running from Verret to Caernarvon. Minor scour repair is also needed adjacent to the railroad closure structure and the sheetpile floodwall, and one of the floodgate's pedestals and screw jack also needs repair. Other miscellaneous work includes removing marsh grass debris and re-establishing turf on damaged sections of the levee.

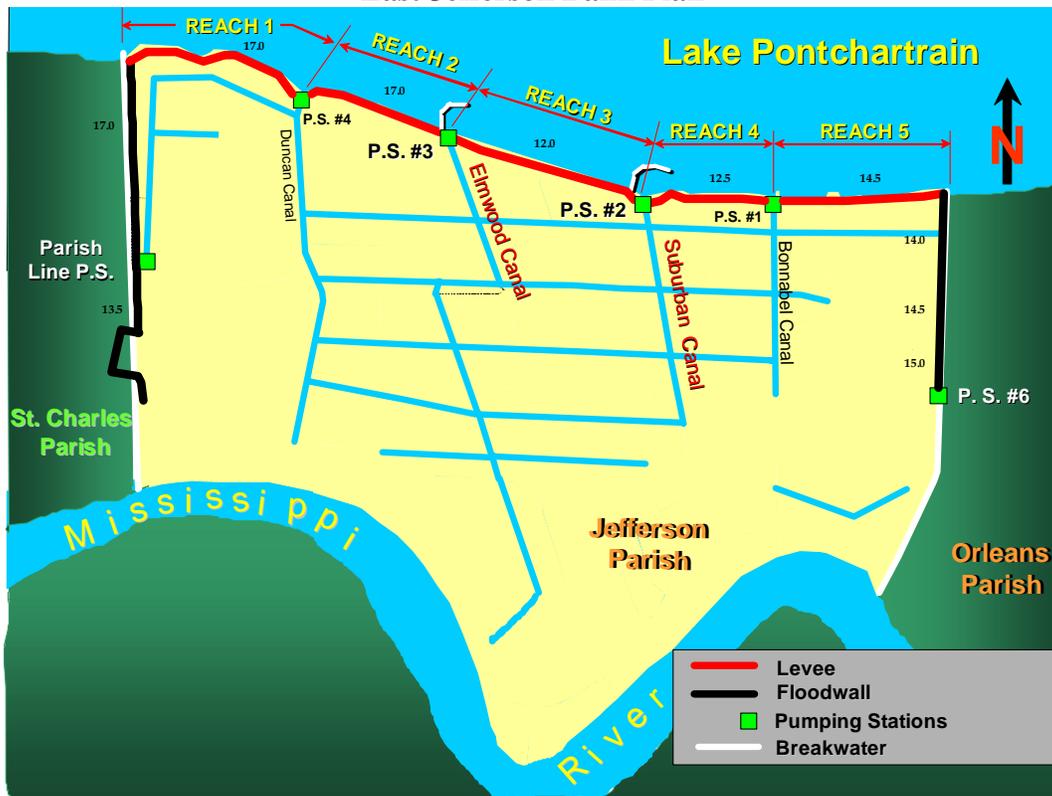
**Figure 5  
East Jefferson Bank Plan**

The East Jefferson Bank Lakefront Hurricane Protection sustained damage by Hurricane Katrina in late August 2005. The flood event produced storm surge levels at the Lake Pontchartrain levee of ranging from 13.0 to 14.0 ft NAVD 88. Minor damages occurred along the Lakefront levees and floodwalls, the Kenner Return Levee, and the west side of the 17<sup>th</sup> Street Canal floodwall. The recommended plan is to rebuild the levees, floodwalls, and control structures to their authorized project grade.

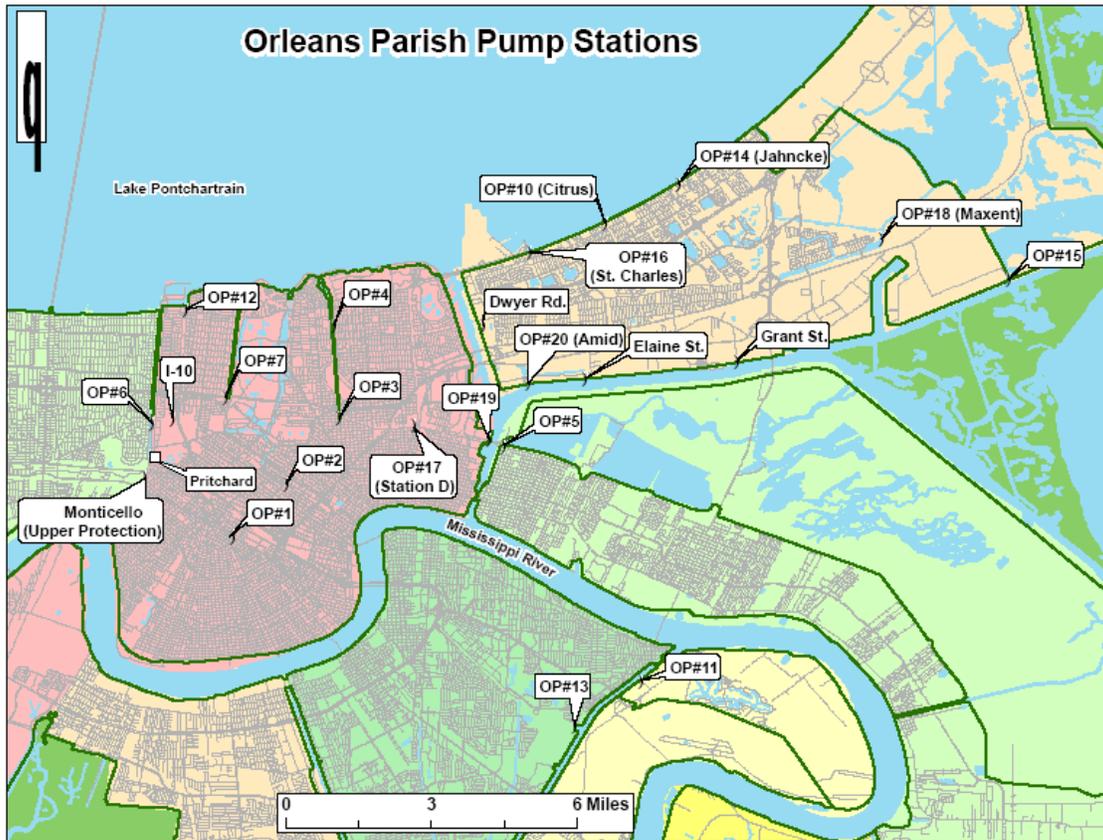
**Figure 8**  
**Orleans Parish Pump Stations**

Orleans Parish pump stations were damaged by Hurricane Katrina when it made landfall near Buras-Triumph, immediately southeast of Jefferson Parish on August 29, 2005. The following outlines the damages that the pump stations incurred. The recommended alternative is to repair the stations to their pre-storm condition.

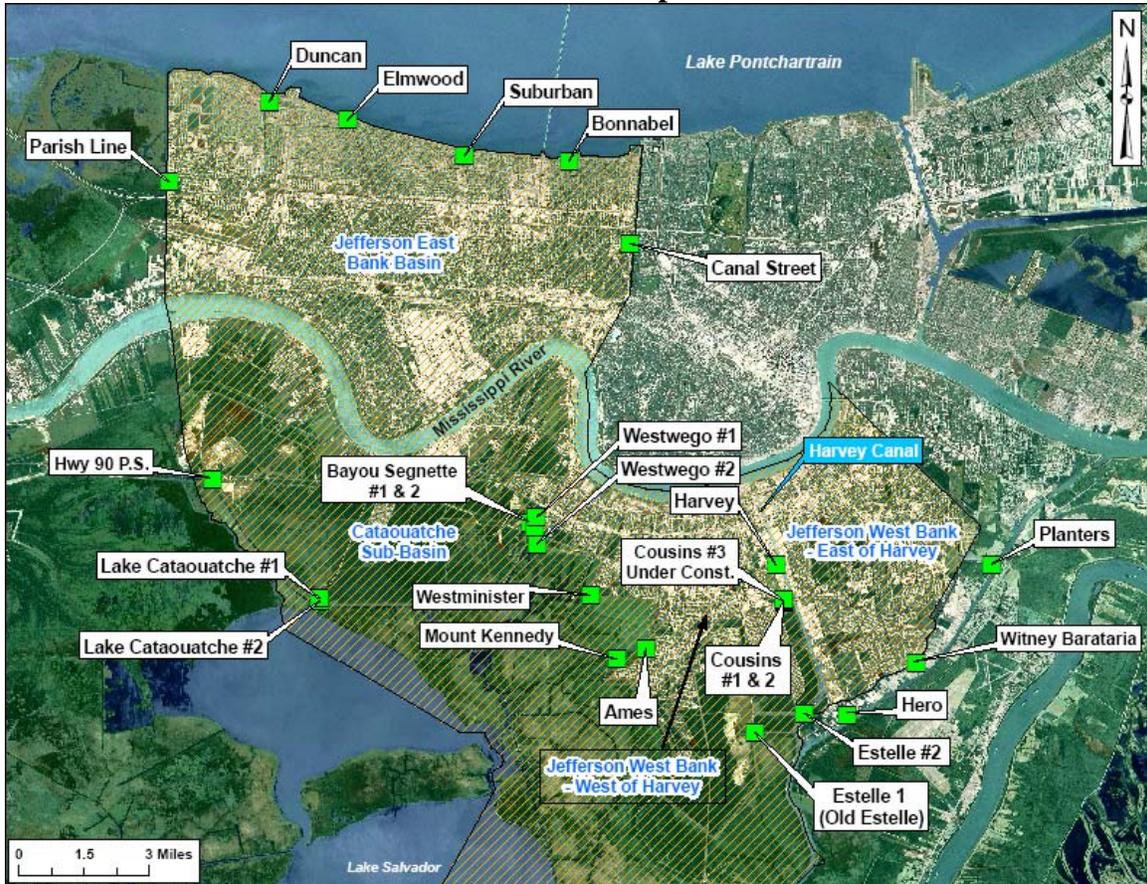
**Figure 9**  
**Jefferson Parish Pump Stations**

The pump stations in Jefferson Parish were damaged by Hurricane Katrina when the storm made landfall near Buras-Triumph immediately southeast of Jefferson Parish on August 29, 2005. The recommended alternative is to repair these stations to their pre-storm condition.

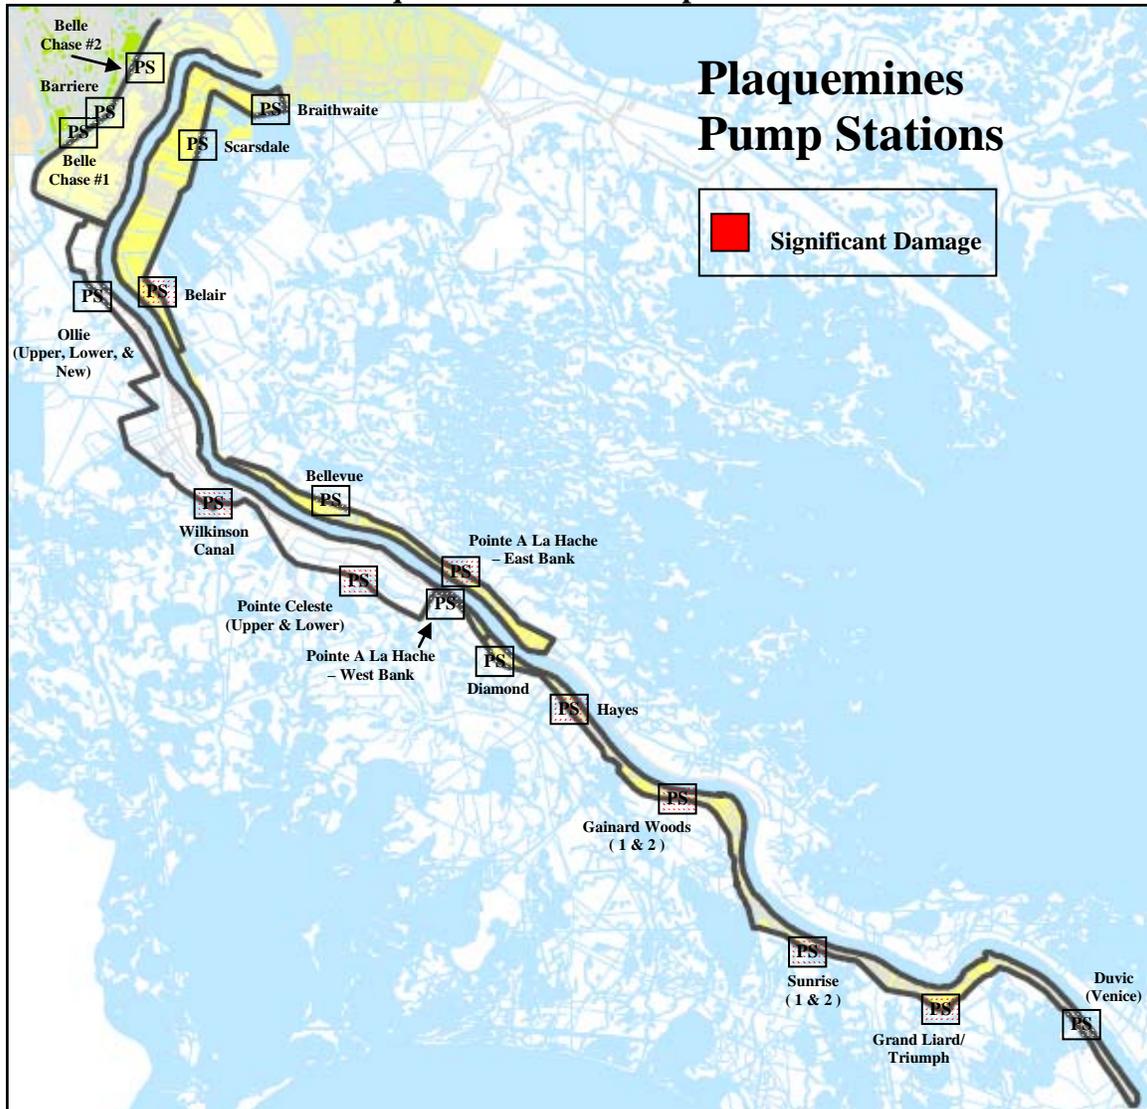
**Figure 10**  
**Plaquemines Parish Pump Stations**

Plaquemines Parish's pump stations were damaged by Hurricane Katrina when the storm made landfall near Buras-Triumph on August 29, 2005. Overtopping and breaching of both the east and west bank back levees and the Mississippi River levees occurred, causing significant flood damage to the pump stations. The pump stations also experienced damage from the high winds and wind-driven water. It is recommended that

this project undergo structural repair and that its diesel engines be elevated as described below.

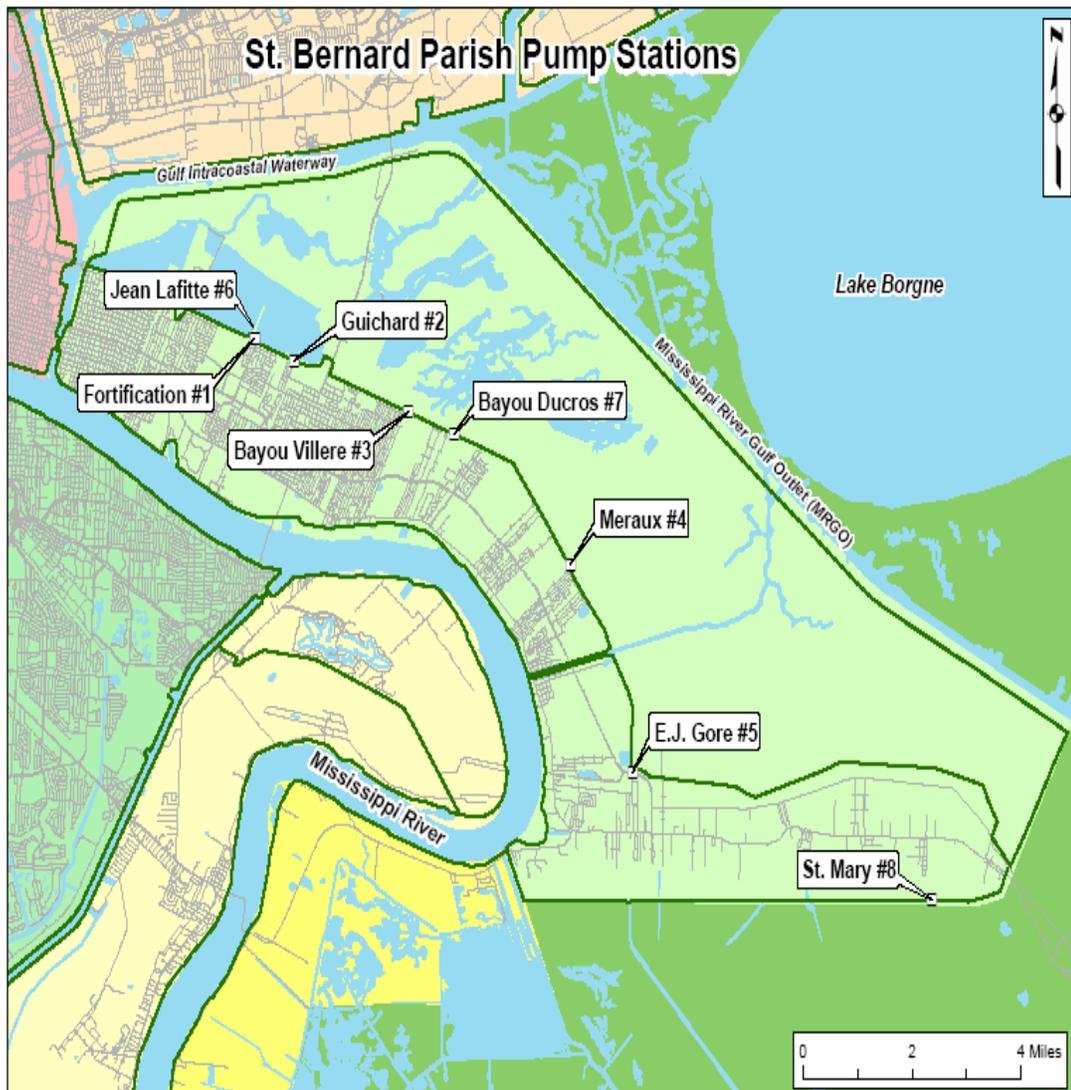
**Figure 11**  
**St. Bernard Pump Stations**

Five of the eight pump stations were only partially affected by flooding from the storm event. The operating floors of these five pumps stations were elevated approximately 12 feet above the ground surface, thereby avoiding the floodwaters. Three stations constructed at the elevation of the protected side toe of the interior back levee had an operating floor only marginally above natural ground and were completely inundated. They will require major rehabilitation/replacement. These three stations, Pump Stations 2, 3, and 5, provide approximately 20 percent of the system's drainage capacity.

The recommended alternative is to repair or replace damage caused by Katrina at Pump Stations 1, 4, 6, 7, and 8; to construct a new elevated building for Pump Stations 2 and 3; and elevate the diesel engines in place at Pump Station 5.
