APPENDIX E
REGULATORY RECORDS

Final Corrective Action Report
Lincoln Beach, 14001 Hayne Boulevard, New Orleans, LA
LDEQ AI#: 93800

**Re: Lincoln Beach PCB Remediation Completion;
MMG File #: 2120-PCB, 2211-A-CNO**

Corrective Action Plan Report – Lincoln Beach
14001 Hayne Blvd., New Orleans, LA

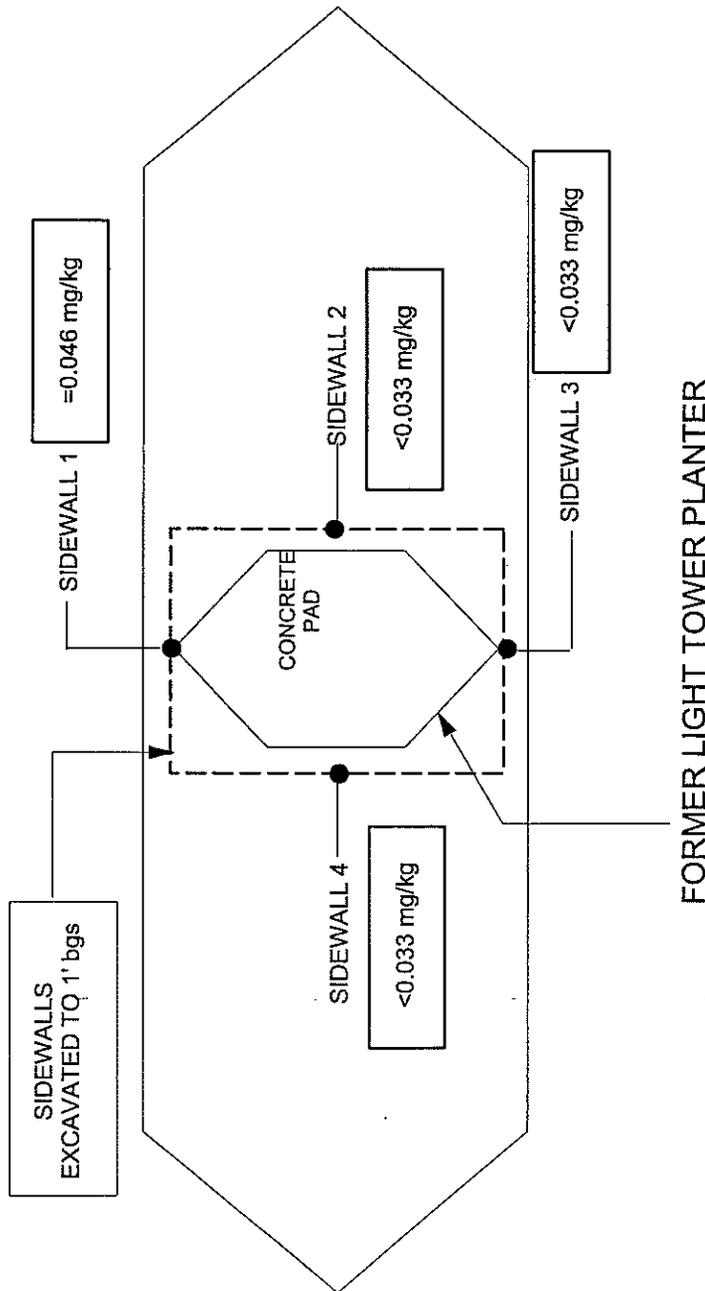
LIGHT TOWER-4

1. The two excavation areas at EV-1 were merged into one excavation area (see Figure 4a).
2. The construction of light towers LT-3, LT-4, and LT-5 prevented confirmatory sampling of the bottom of the excavation (the concrete foundation could not be removed). Only the four sidewalls were sampled at these locations.

NOTE: NO BOTTOM OF PIT SAMPLE COLLECTED

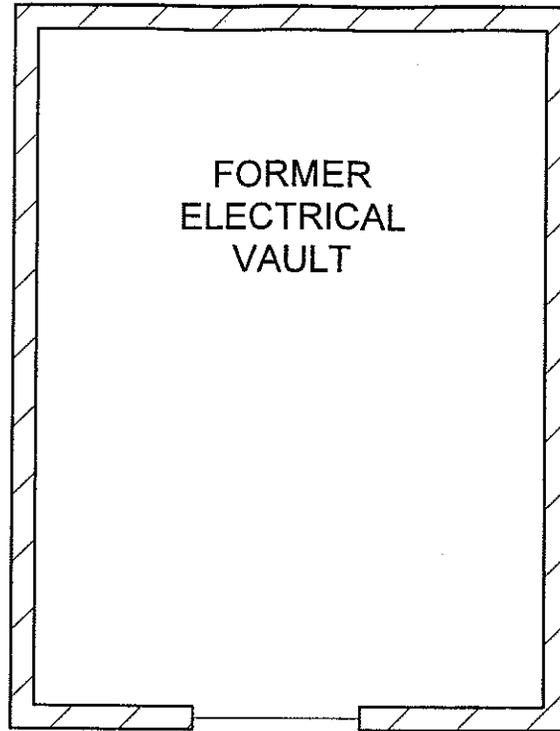
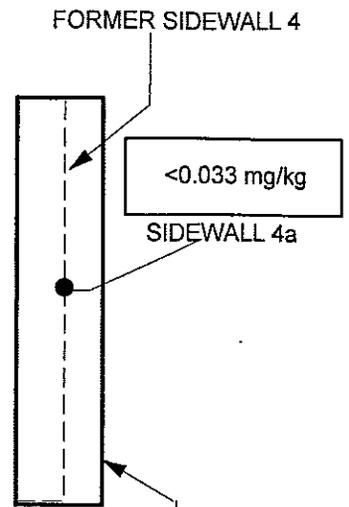
DRAWN: BEN TSAI FILE: 2211-PCB	FIGURE:6a: ELECTRICAL VAULT EV-1 FINAL EXCAVATION AREA / CONFIRMATORY SAMPLE LOCATION	MATERIALS MANAGEMENT GROUP
	LINCOLN BEACH PCB CLEANUP SEPT. 2003	3520 GENERAL DEGAULLE SUITE 3010 NEW ORLEANS, LOUISIANA 70114 PHONE: 504-368-0568, FAX:368-8403

FINAL EXCAVATION AREA -
EXCAVATED ADDITIONAL 3ft. bgs
(TOTAL EXCAVATION= 6ft. bgs)

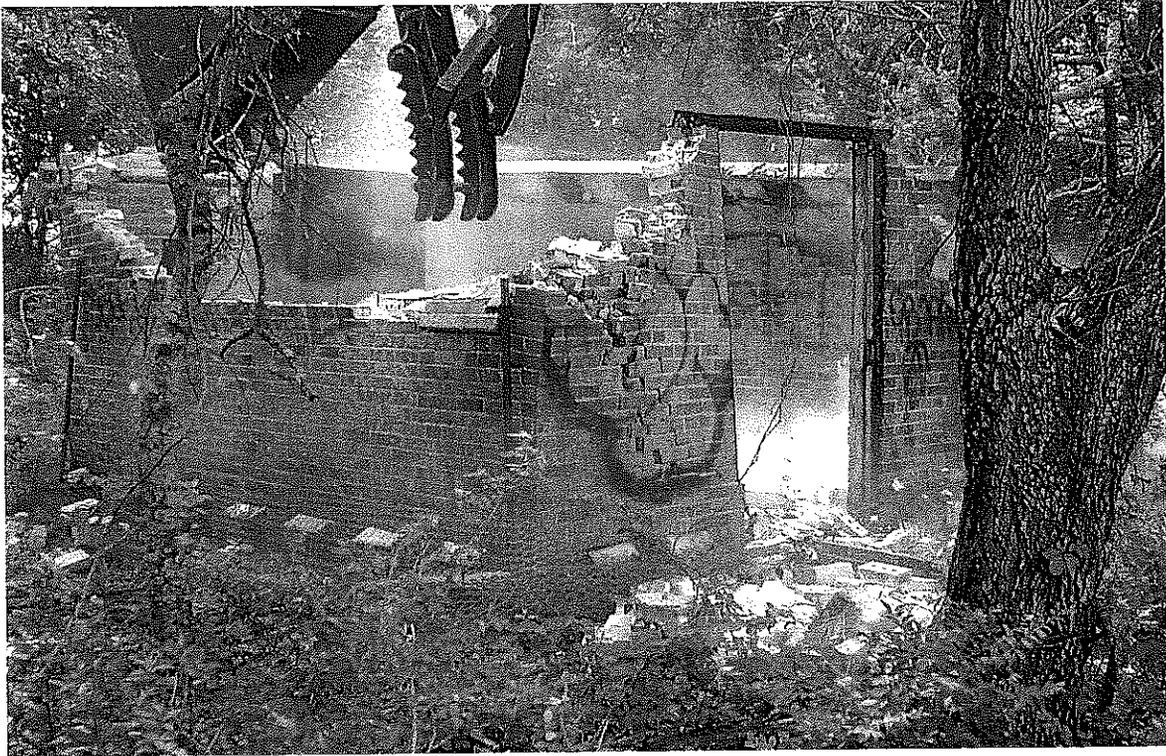
Photo 1: Electrical Vault Demolition

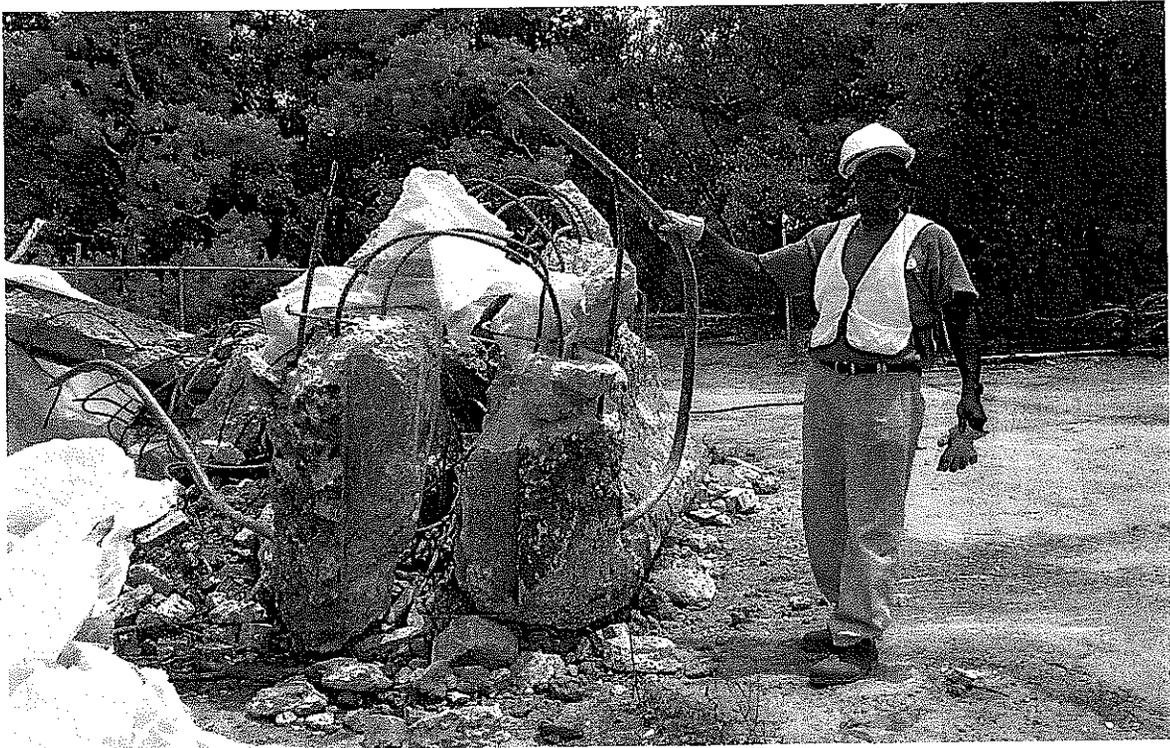
Photo 2: Stockpiled Electrical Vault Foundation

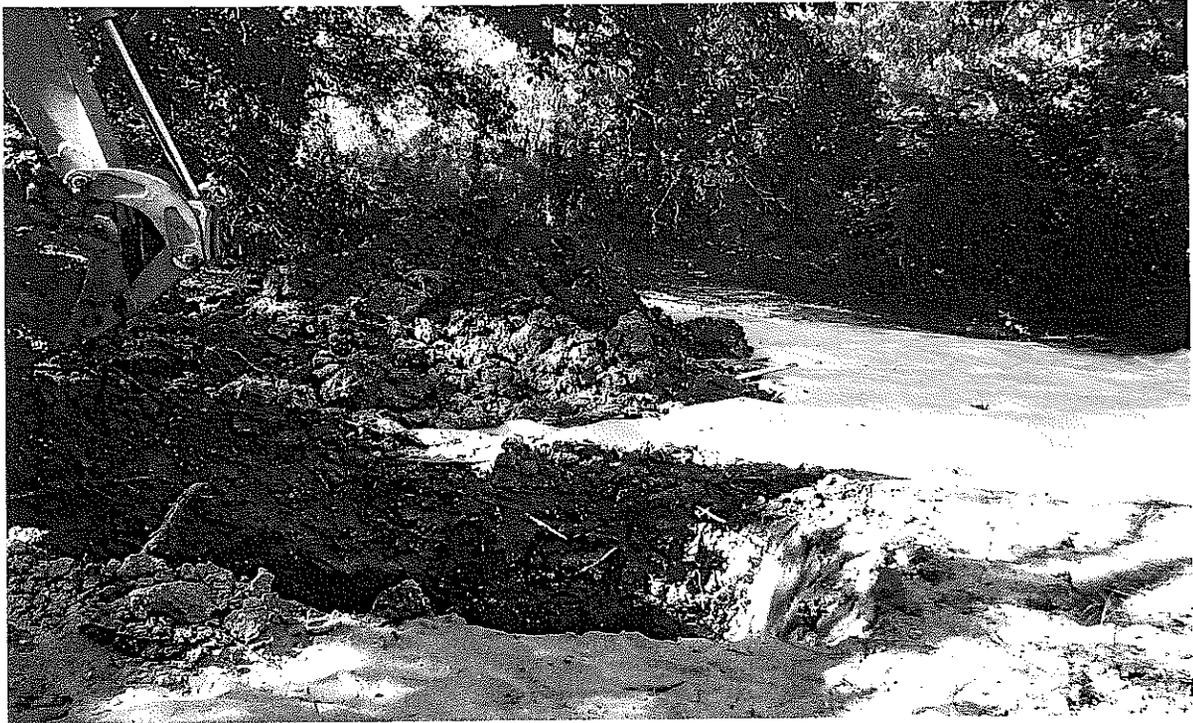
Photo 3: Excavation at Electrical Vault EV-1

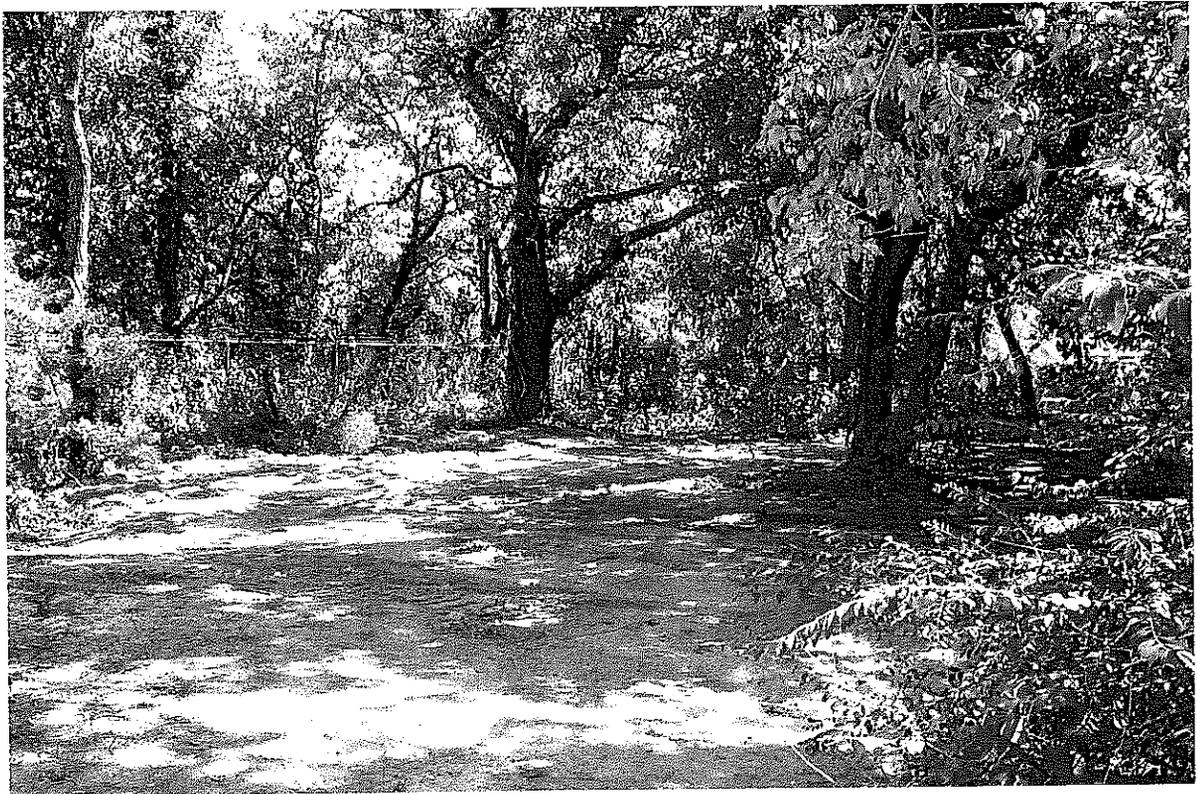
Photo 4: Former Electrical Vault (EV-4) Area

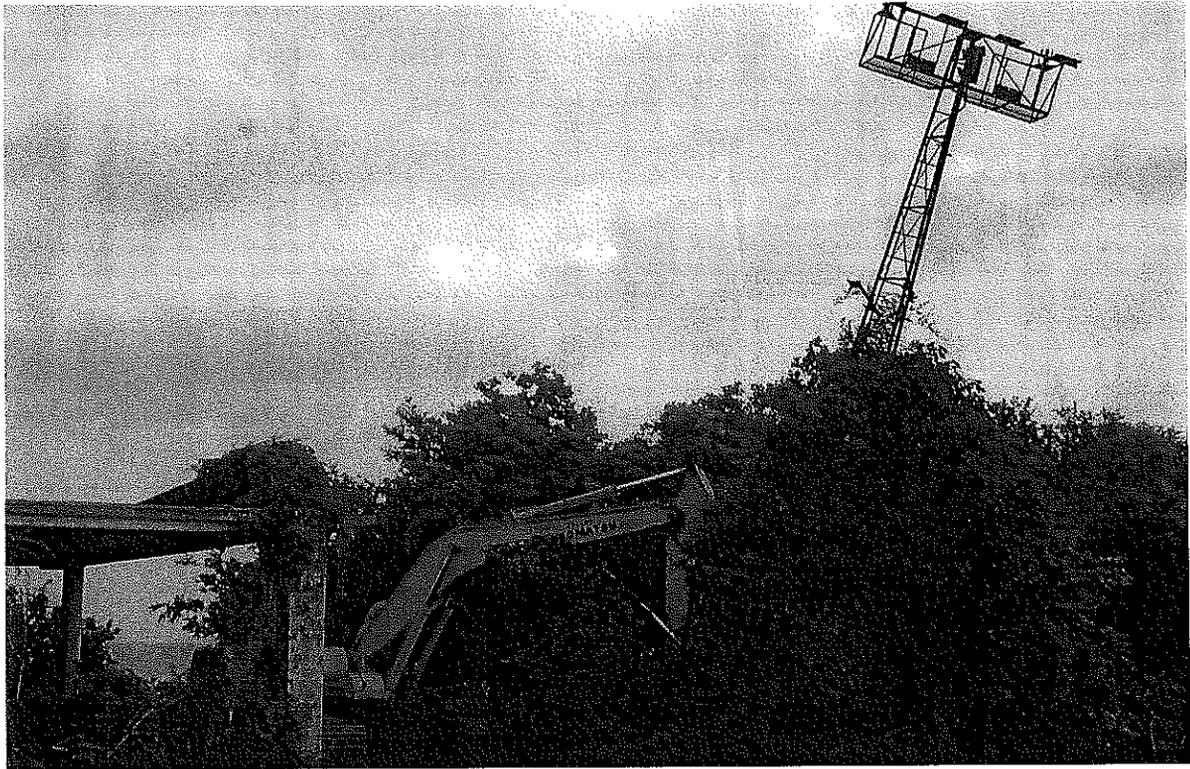
Photo 5: Light Tower Demolition

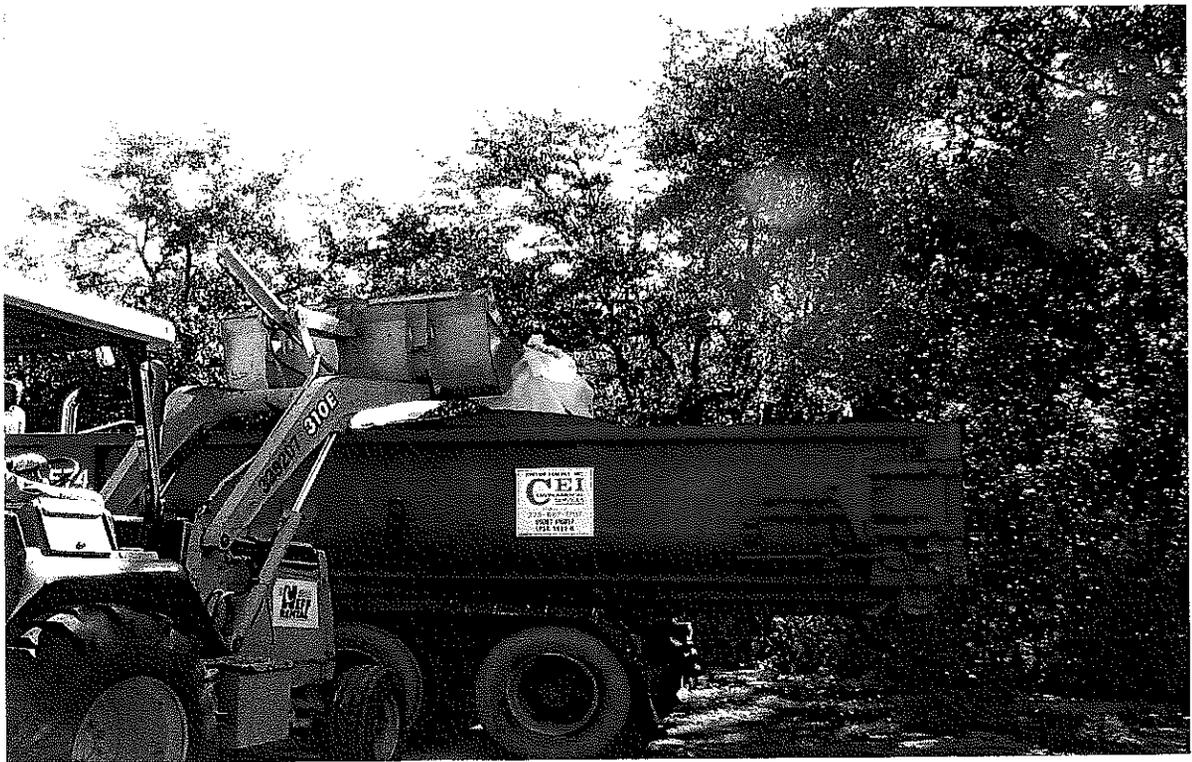
Photo 6: Waste Load Out
