APPENDIX C
PHOTOGRAPHS

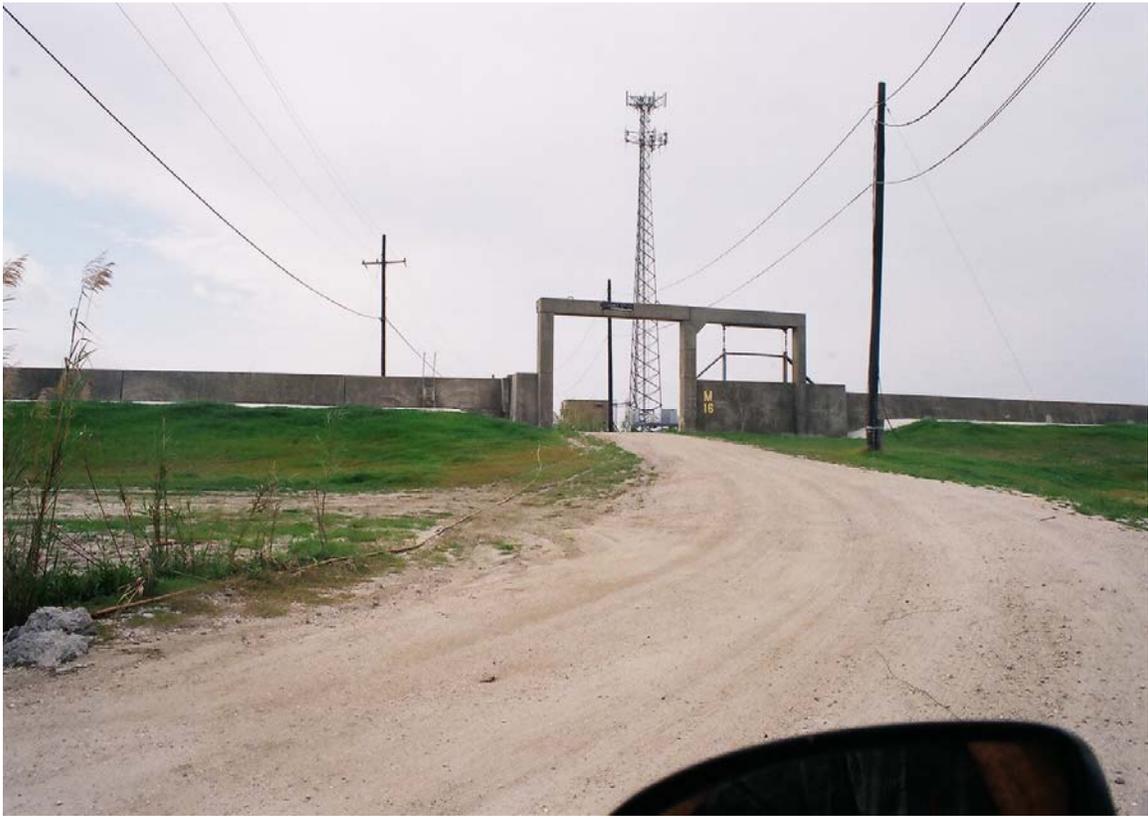
Photo 1 – View south. Gate at western terminus of LPV 111.

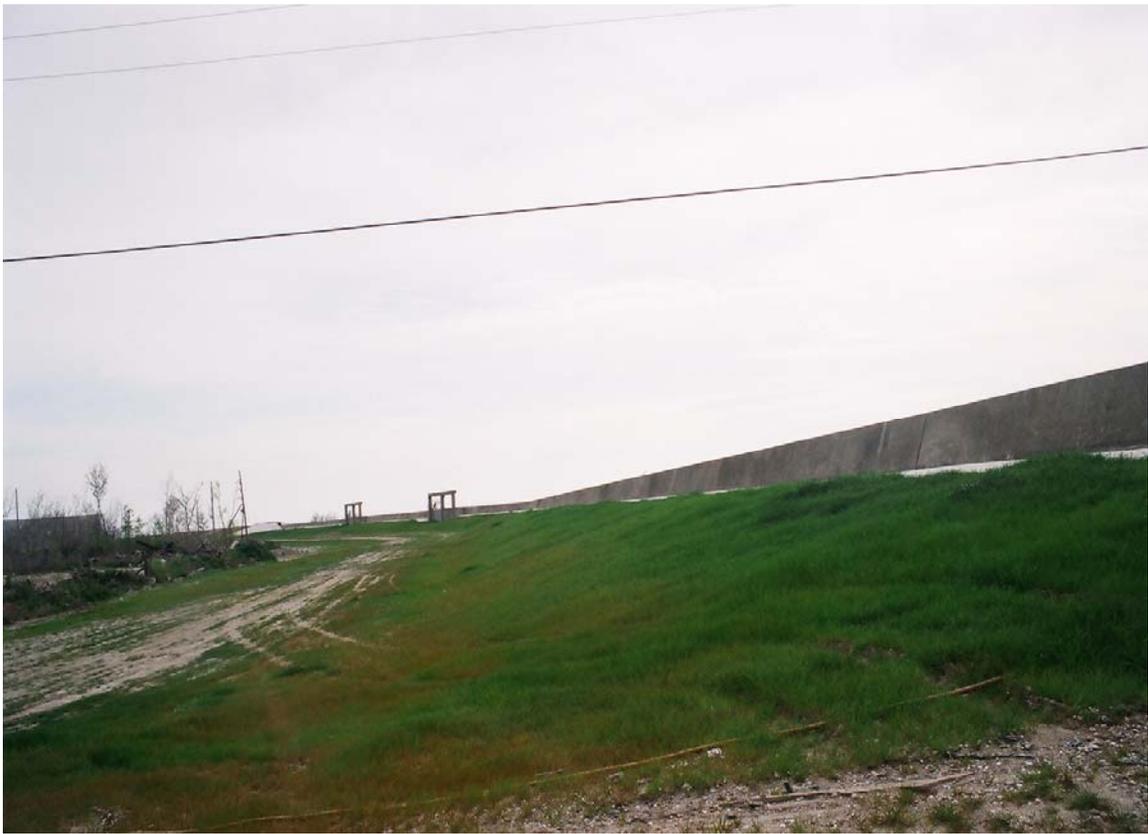
Photo 2 – View west. LPV 111 Floodwall north side.

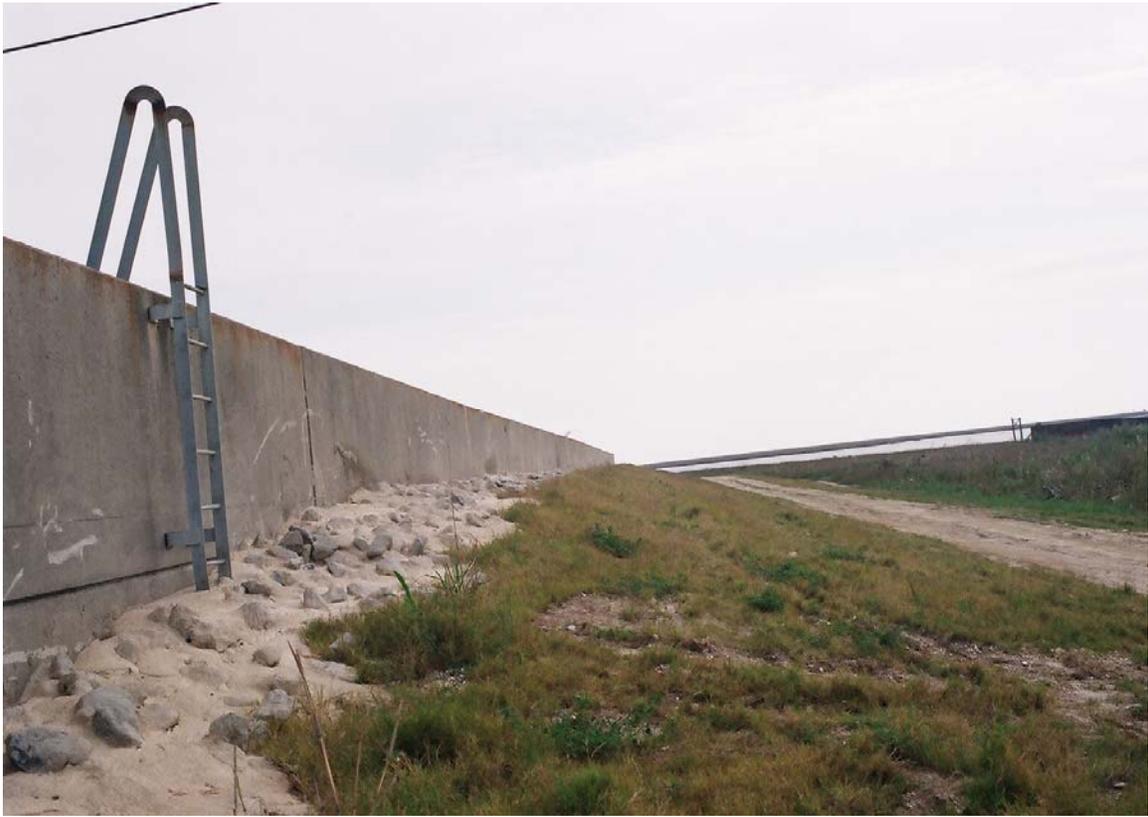
Photo 3 – View west. LPV 111 Floodwall south side.

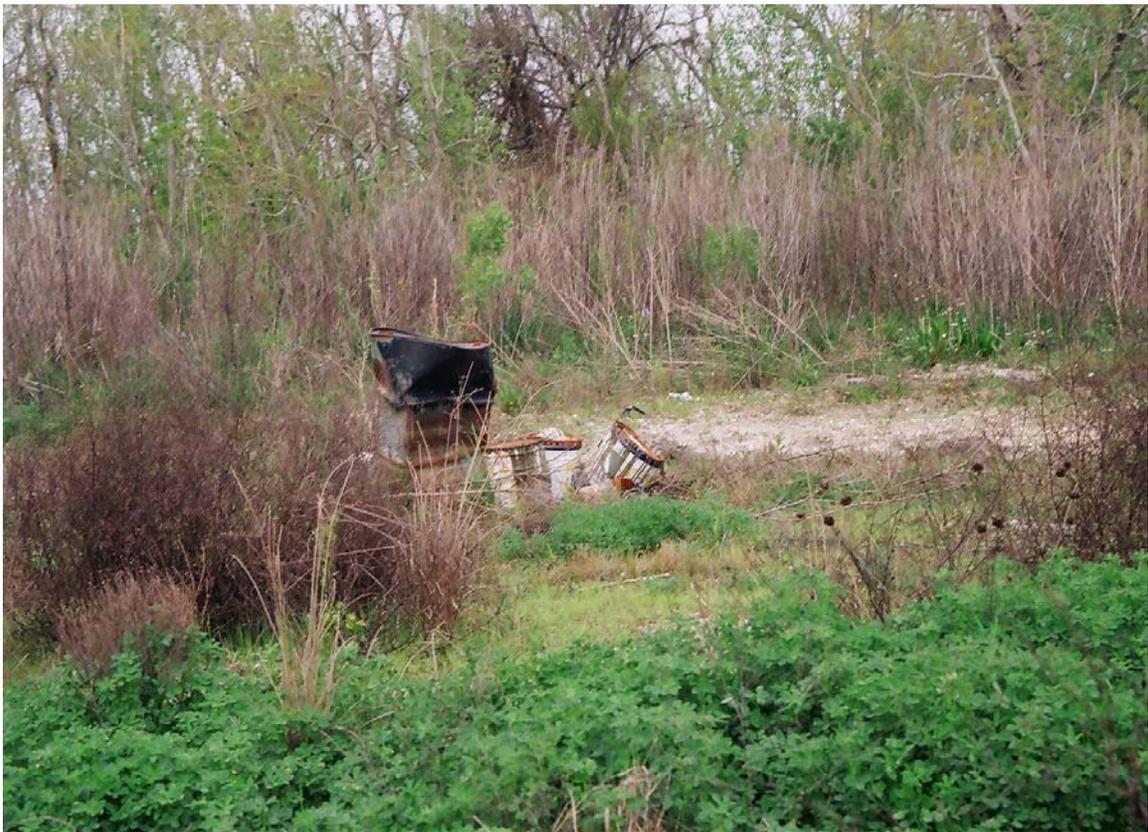
Photo 4 – View north. 55-gallon drum and buckets containing tar.

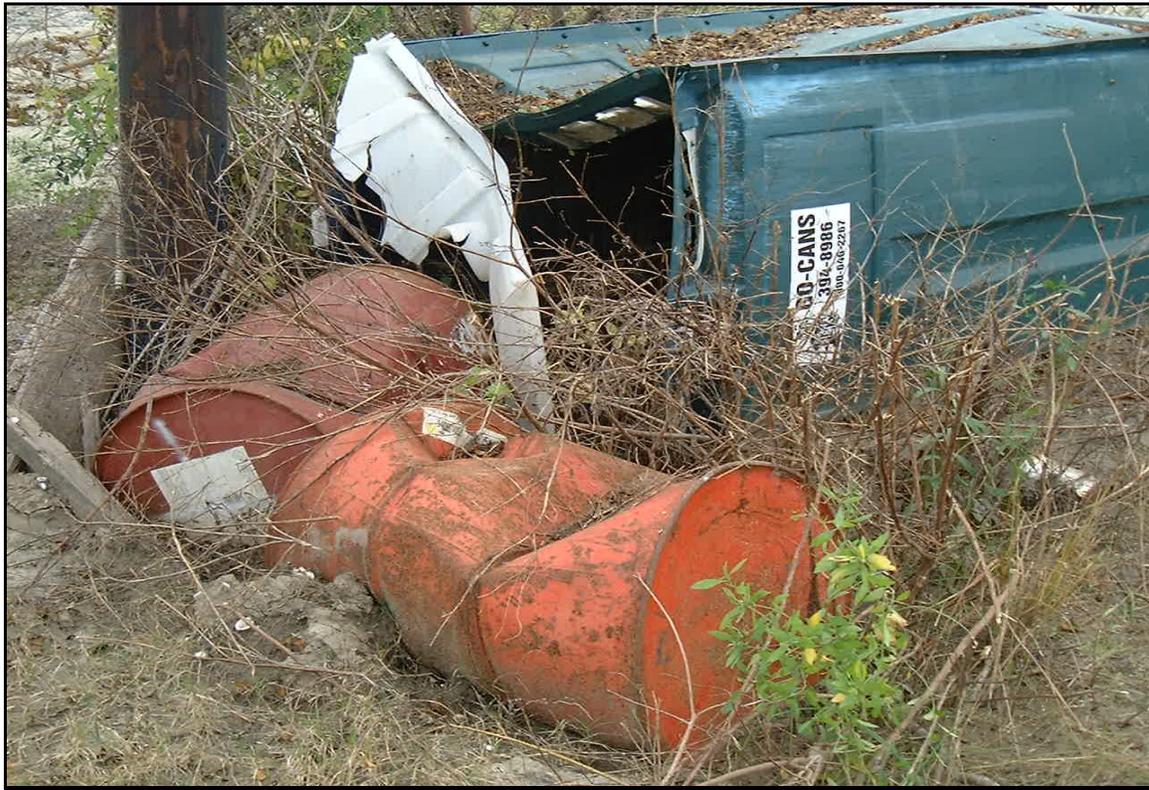
Photo 5 – View north. Empty lubricant drums and Port-A-John at southeast corner of BOC Gases.

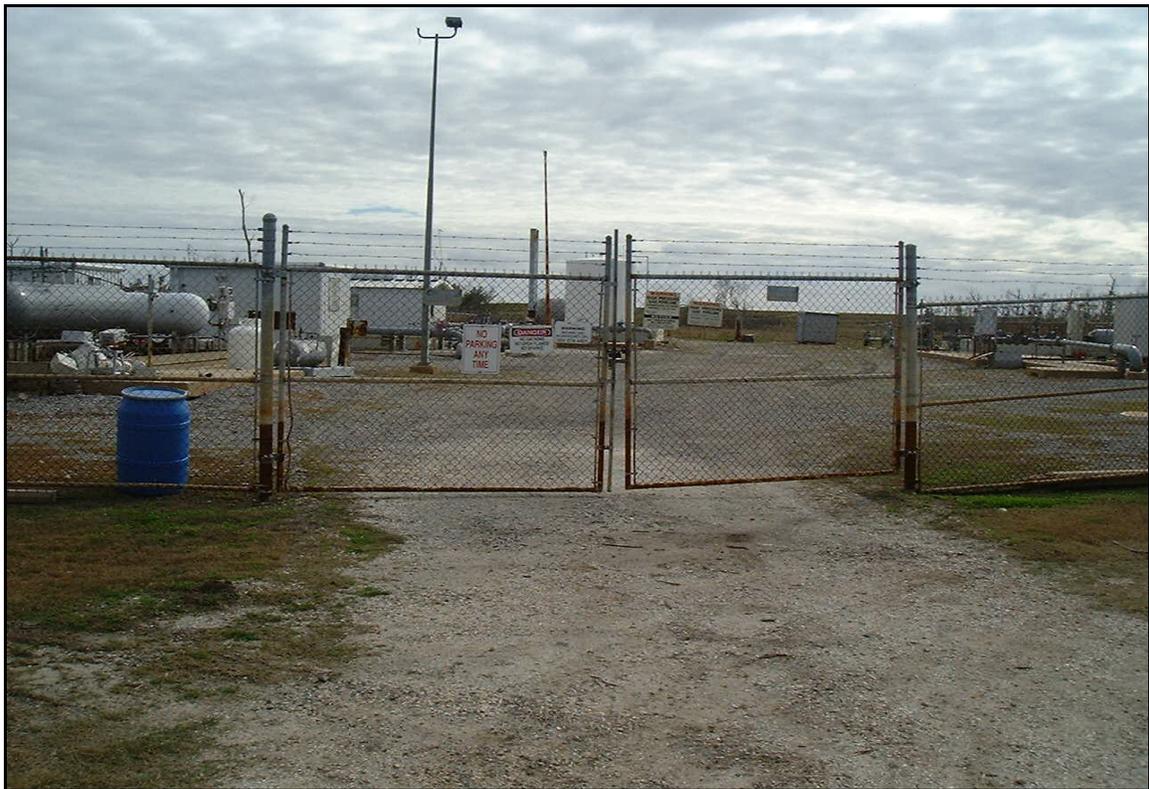
Photo 6 –View south. Entergy/Southern Natural Gas pumping station. Levee LPV 111 is in the background.

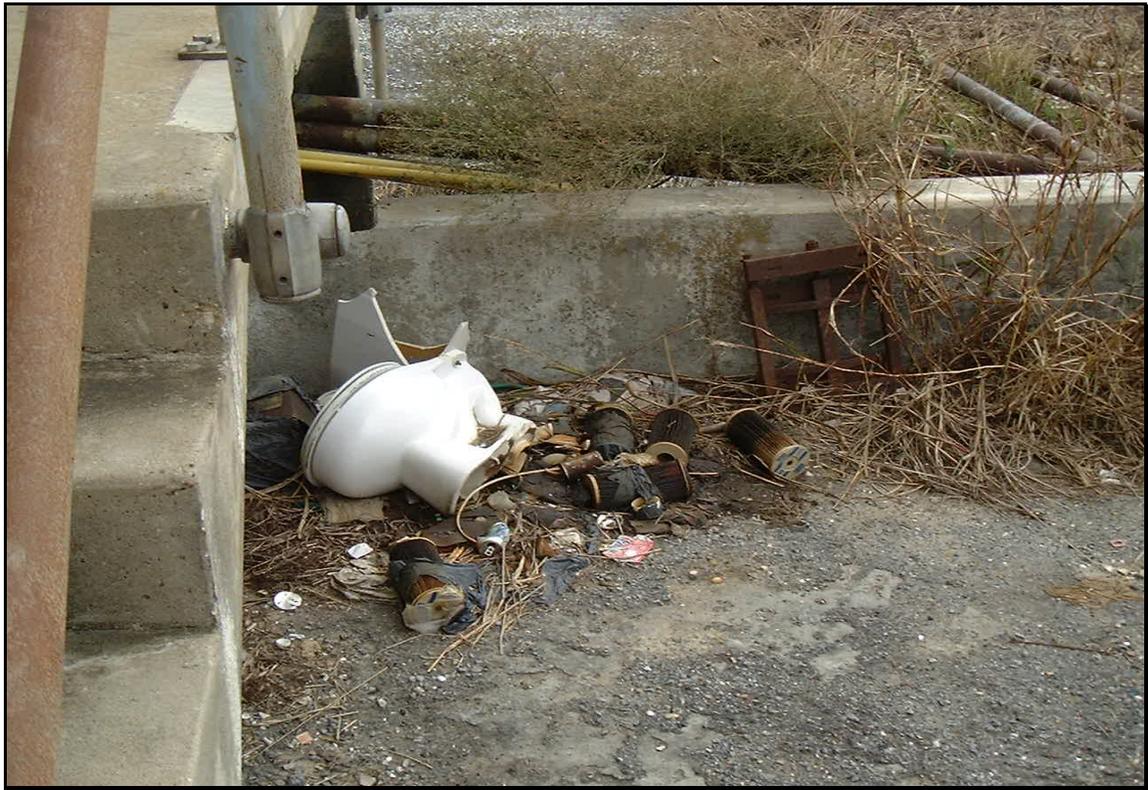
Photo 7 – Canal Pump House No. 1 near center of LPV 111. Apparently discarded filters and minor surface staining.

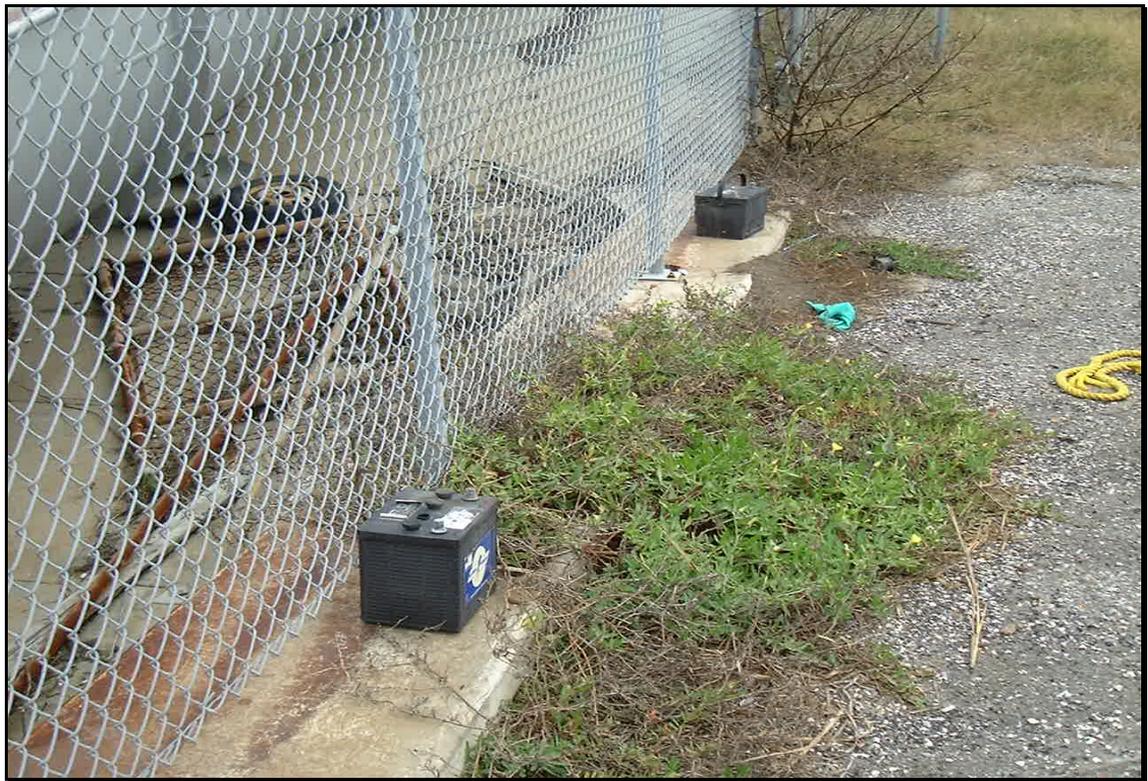
Photo 8 – Lead acid batteries apparently abandoned outside Canal Pump House No. 1 near center of LPV 111.

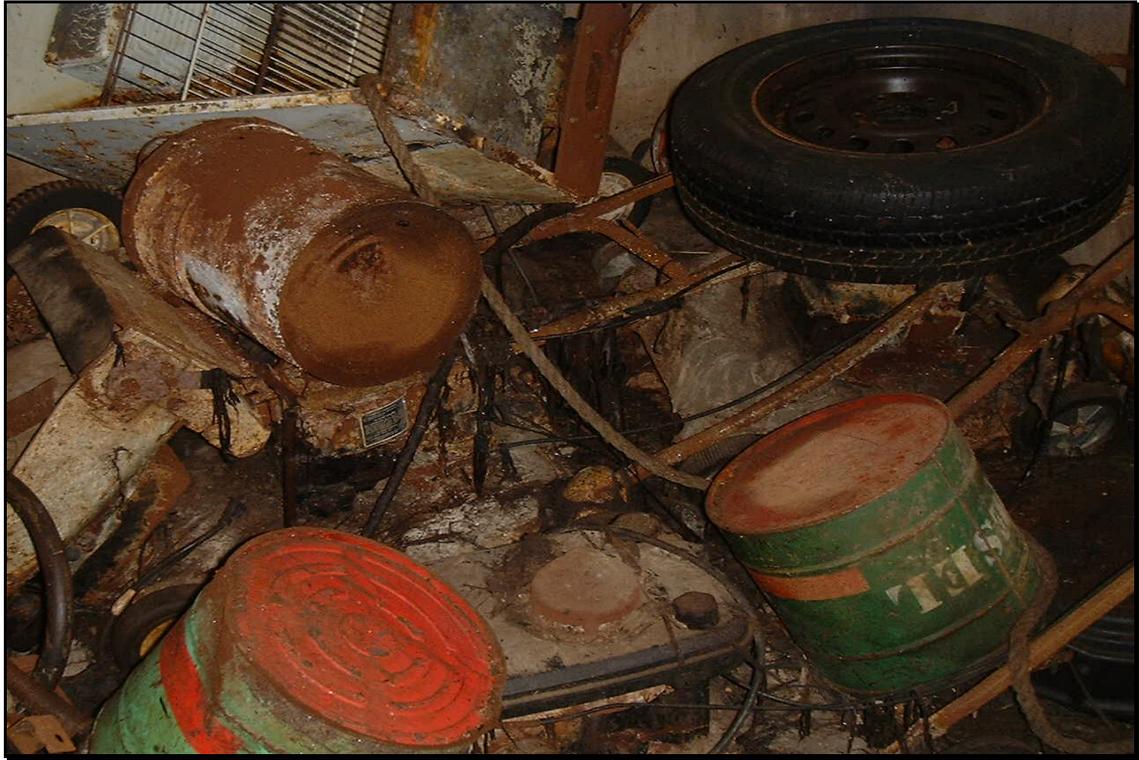
Photo 9 – Several drums labeled for storage of diesel and lubricants, lawn mowers, string trimmers inside Canal Pump House No. 1 near center of LPV 111.

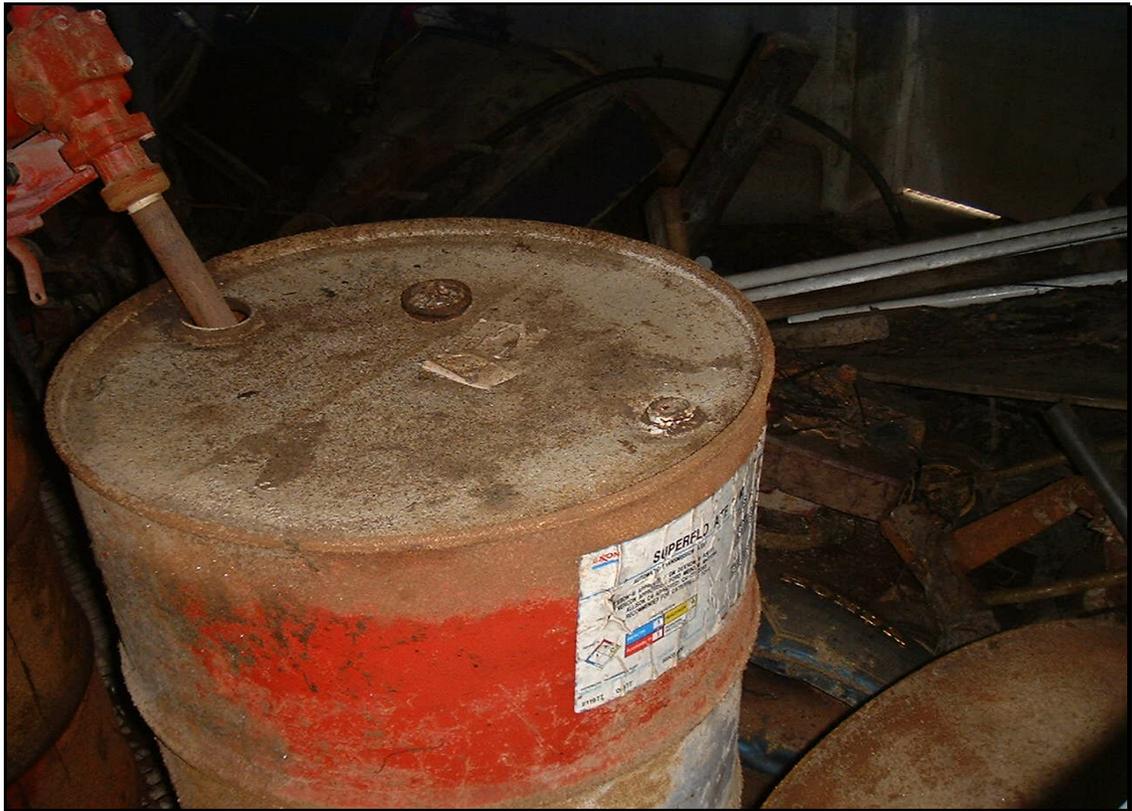
Photo 10 – Open drums labeled for storage of lubricants inside Canal Pump House No. 1 near center of LPV 111.

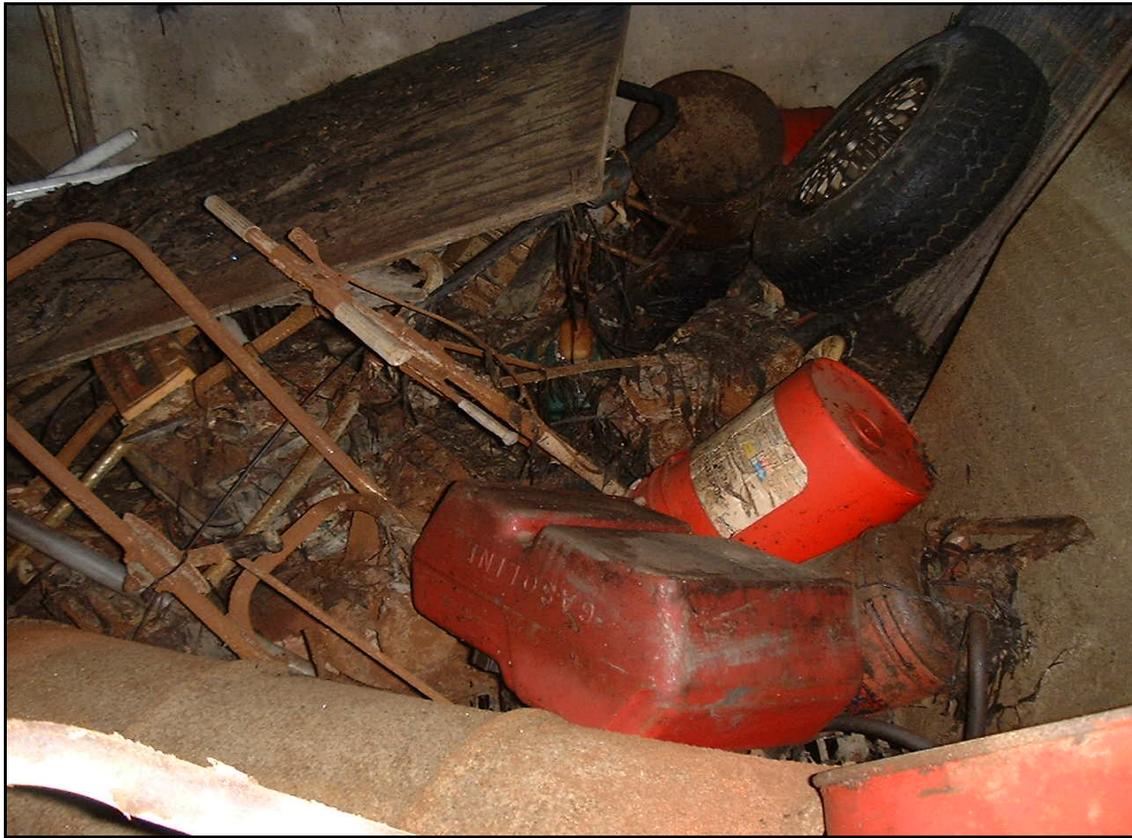
Photo 11 – Drums and smaller containers labeled for storage of gasoline, diesel and lubricants, lawn mowers, string trimmers inside Canal Pump House No. 1 near center of LPV 111.
