**HTRW PHASE I
ENVIRONMENTAL SITE ASSESSMENT**

**ORLEANS AVENUE CANAL
ORLEANS PARISH
NEW ORLEANS, LOUISIANA**

**U.S. Army Corps of Engineers
New Orleans District
New Orleans, Louisiana**

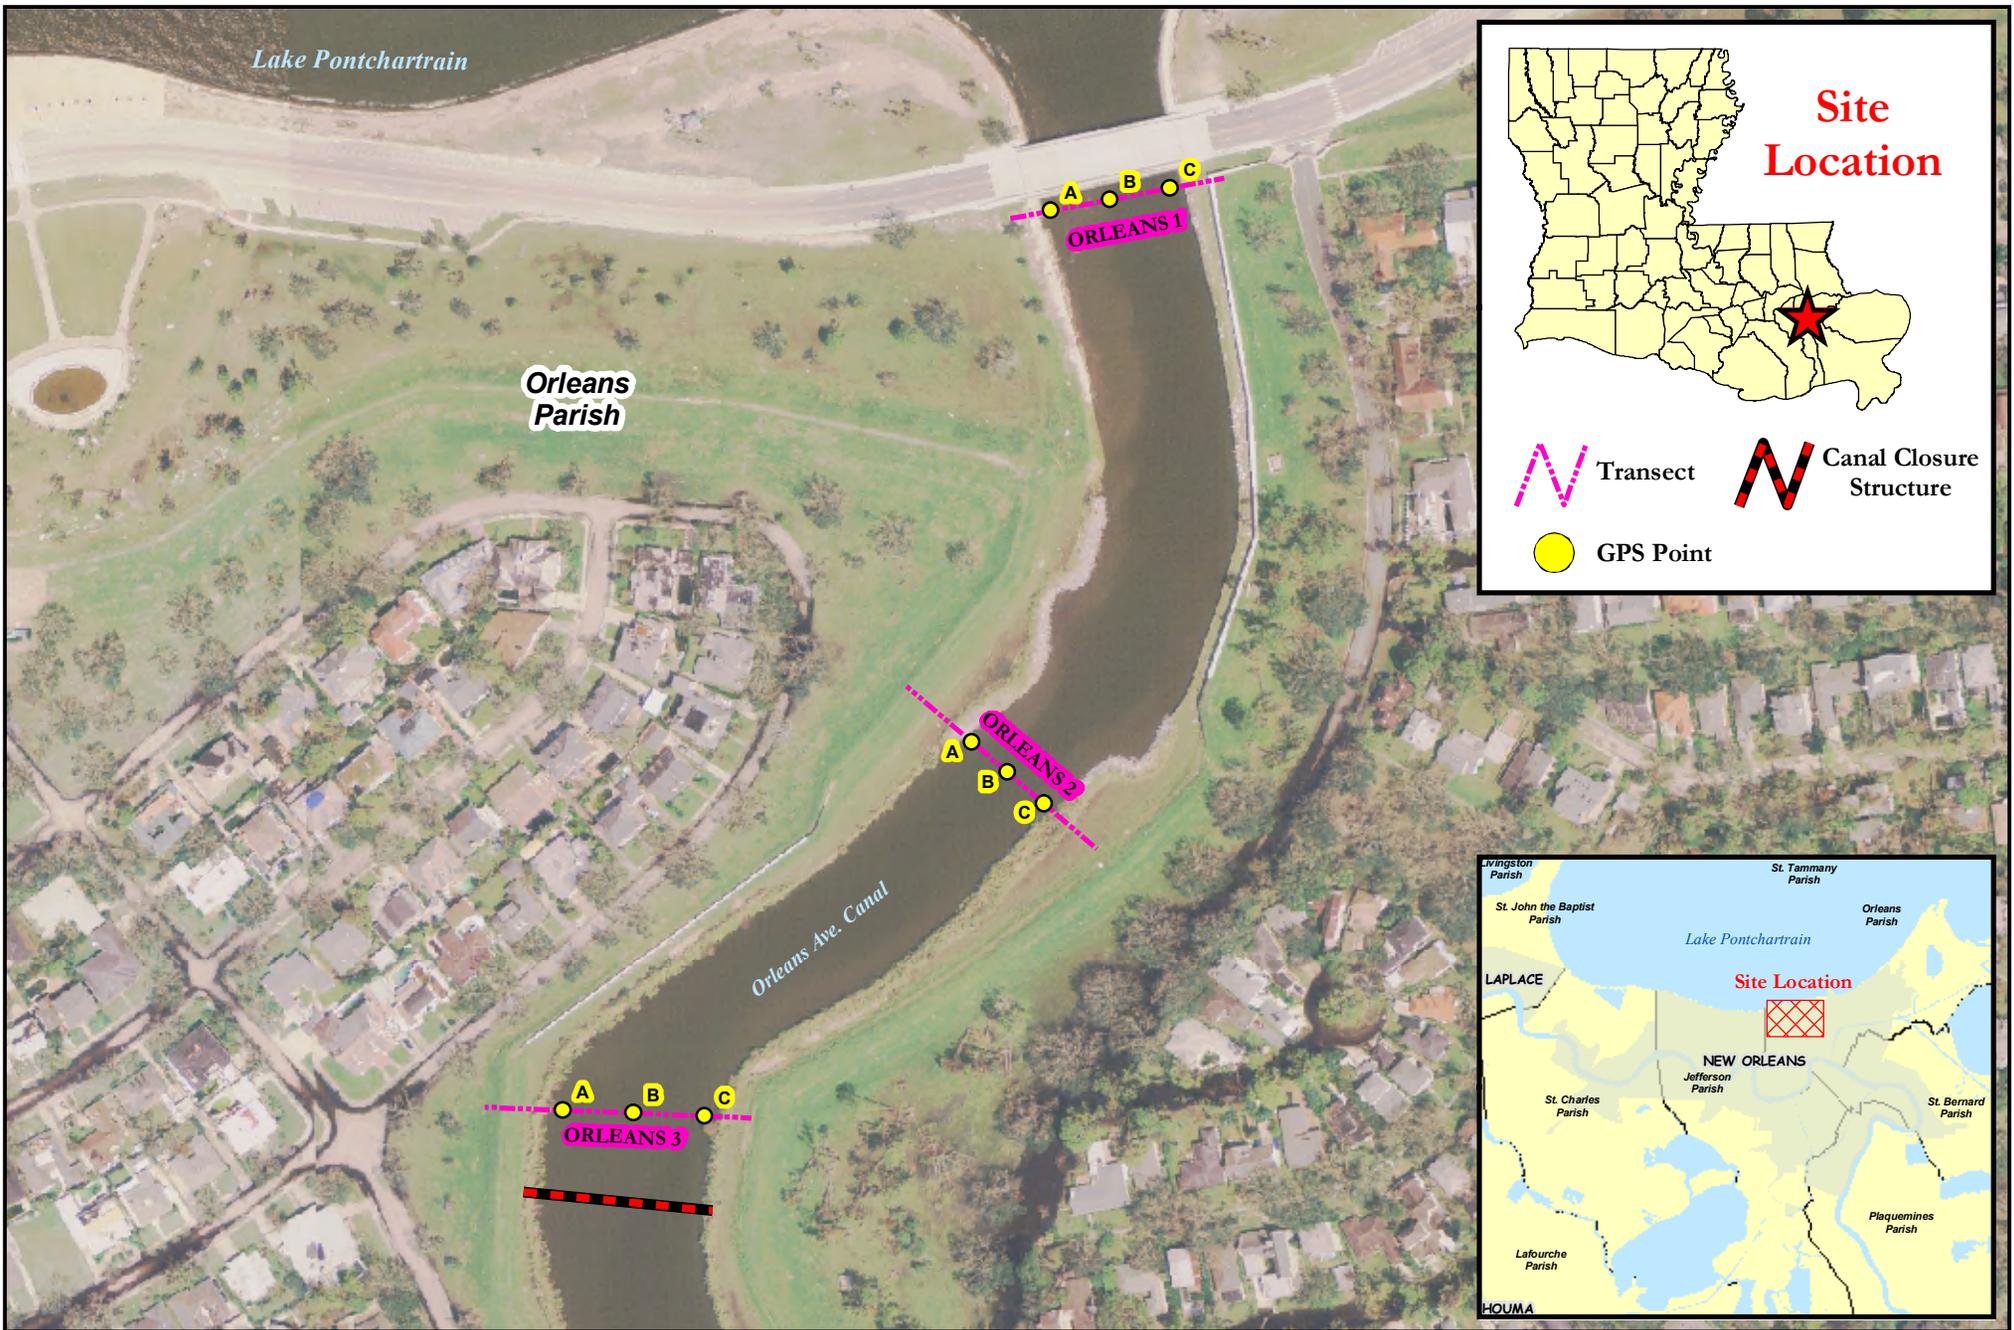
CIH INVESTIGATION SAMPLING LOCATIONS

Laboratory analyses of the composite samples revealed the presence of contaminants in levels potentially hazardous to human health at all three sampling locations. Sample ORLEANS 1, the northernmost sampling location, contained lead concentrations exceeding LDEQ Risk Evaluation/Corrective Action Program (RECAP) screening standards by 70 mg/kg (70 percent). TPH-Diesel Range Organics (DRO) and Oil Range Organics (ORO) were found to exceed RECAP standards by 205 mg/kg (315 percent) and 210 mg/kg (117 percent) in sample ORLEANS 2 (the middle sampling location) and by 155 mg/kg (238 percent) and 111 mg/kg (62 percent) in sample ORLEANS 3 (the southernmost sampling location). None of the analyzed compounds regulated by RCRA were present in the Orleans Avenue Canal TCLP samples in concentrations exceeding RCRA standards. TPH-DRO and TPH-ORO were detected in the TCLP leachate in the ORLEANS 1 sample, and TPH-DRO was detected in the ORLEANS 2 and ORLEANS 3 samples. TPH-GRO was also detected in all three samples, possibly due to volatile organic blank contamination.

The results of the laboratory analyses indicated that the material sampled from Orleans Avenue Canal contained PAHs, lead, and total petroleum hydrocarbons in concentrations that are potentially hazardous to human health or the environment. Additionally, the laboratory analyses indicated that dioxins, while not present in concentrations exceeding standards set by the State of Louisiana, are present in the sediments at levels that may preclude certain disposal options. The sampling analysis report recommended further evaluation of the sediment material analysis prior to consideration of ocean dumping or use of the material as borrow or fill. The report further recommended that prior to landfill disposal, the analysis of the sediment be evaluated in order to ensure its disposal in a landfill permitted to dispose of such material, and that personnel handling the sediment material should be outfitted in modified Level D personal protective equipment, including oil-resistant gloves and safety glasses. Additionally, the report stated that special actions associated with state environmental regulations regarding the handling, storage, disposal or ownership of contaminated sediments (as described in Louisiana Administrative Code Title 33:V) may be required.
