PHASE I ENVIRONMENTAL SITE ASSESSMENT

**LONDON AVENUE CANAL
ORLEANS PARISH
NEW ORLEANS, LOUISIANA**

**U.S. Army Corps of Engineers
New Orleans District
New Orleans, Louisiana**

FINAL REPORT

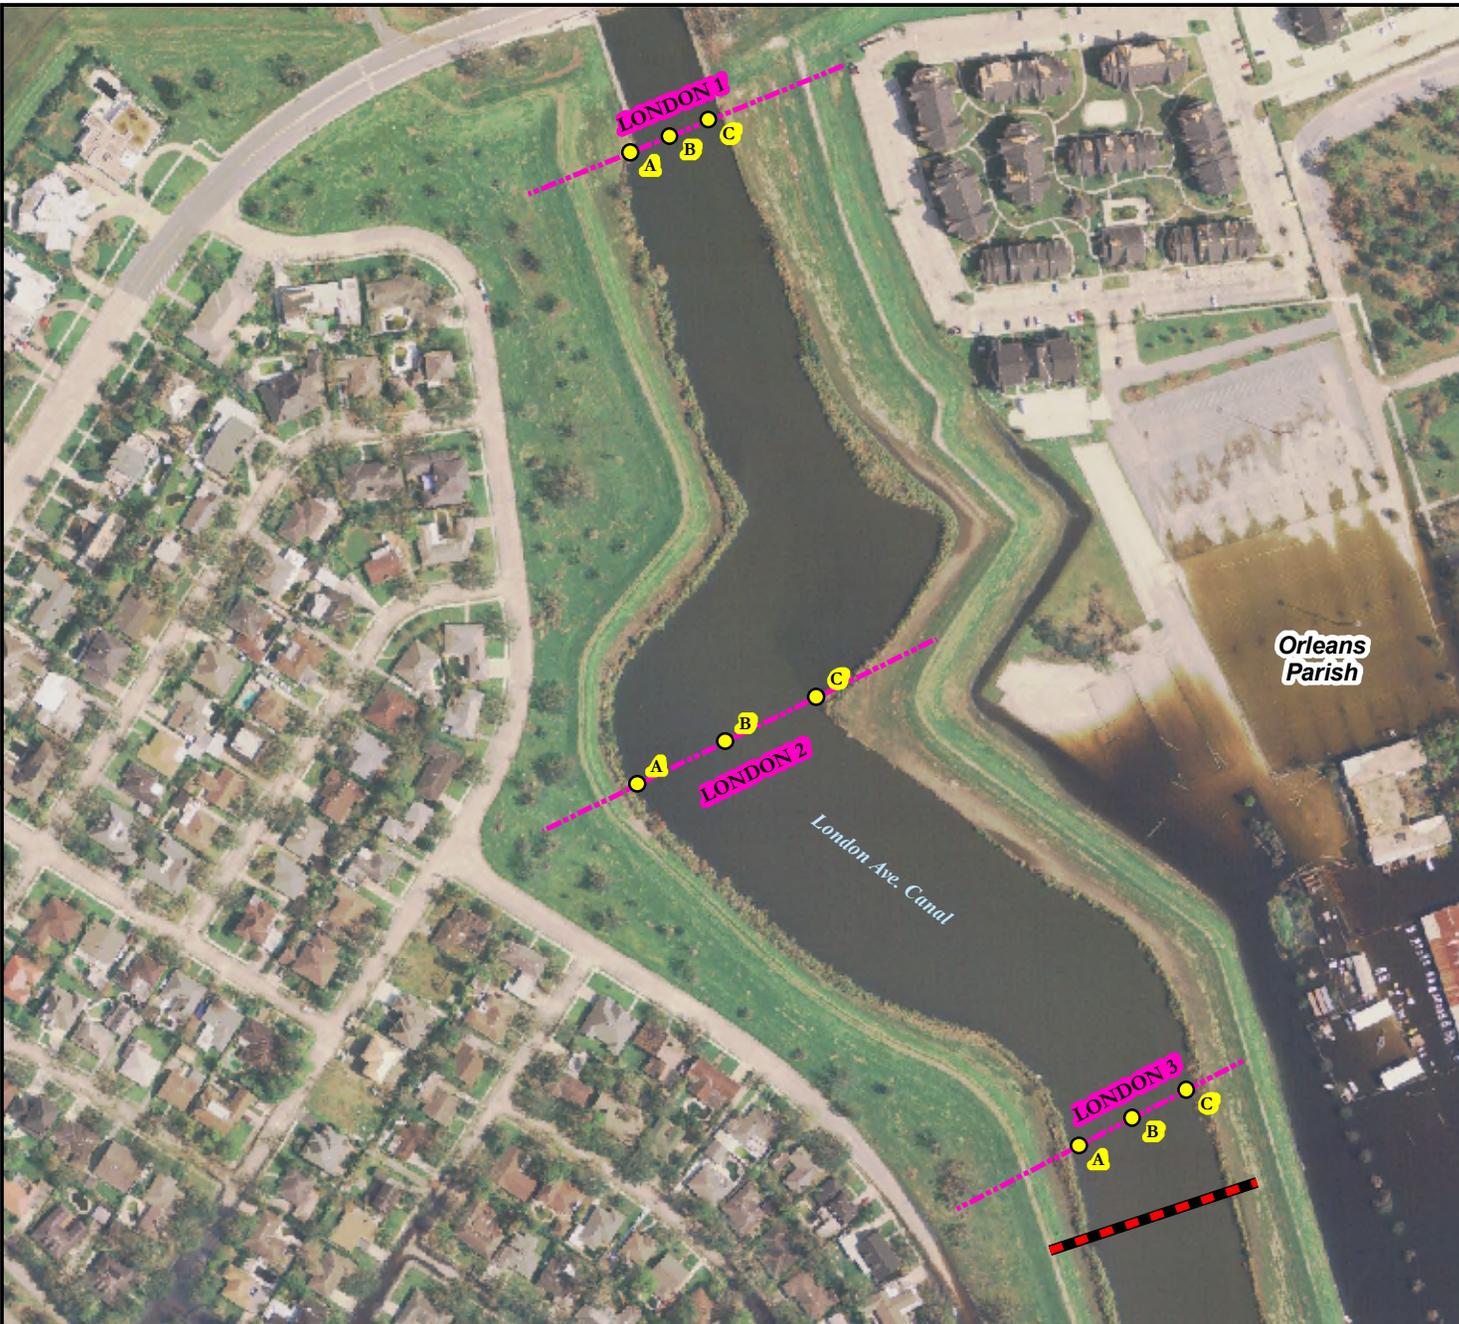
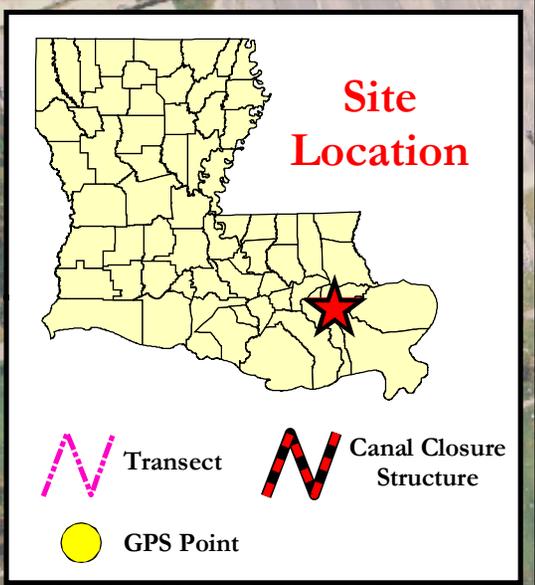
CIH INVESTIGATION SAMPLING LOCATIONS

Sample LONDON 1 exhibits no compounds exceeding RECAP standards with the exception of the blank contamination noted below. Sample LONDON 2 exceeds standards for lead by 85 mg/kg (85 percent), TPH-DRO by 405 mg/kg (623 percent), and TPH-ORO by 940 mg/kg (522 percent). Sample LONDON 3 exceeds standards for TPH-DRO by 356 mg/kg (548 percent) and TPH-ORO by 850 mg/kg (472 percent). Volatile organic blank contamination was also noted in the trip blank for the London Avenue Canal. Falsely elevated concentrations of trichloroethene are noted in the volatile organics analysis for all three composite samples. These falsely elevated volatile detections are also reflected in the TPH-GRO results. None of the analyzed compounds that are regulated by RCRA are present in the London Avenue Canal TCLP samples in concentrations exceeding RCRA standards. TPH-DRO and TPH-ORO were detected in the TCLP leachate in the LONDON 2 sample, and TPH-DRO was detected in the LONDON 1 and LONDON 3 samples. TPH-GRO was also detected in all three samples, possibly due to volatile organic blank contamination.

The results of the laboratory analyses indicated that the material sampled from London Avenue Canal contained PAHs, lead, and total petroleum hydrocarbons in concentrations that are potentially hazardous to human health or the environment. Additionally, the laboratory analyses indicated that dioxins, while not present in concentrations exceeding standards set by the State of Louisiana, are present in the sediments at levels that may preclude certain disposal options. The sampling analysis report recommended further evaluation of the sediment material analysis prior to consideration of ocean dumping or use of the material as borrow or fill. The report further recommended that prior to landfill disposal, the analysis of the sediment be evaluated in order to ensure its disposal in a landfill permitted to dispose of such material, and that personnel handling the sediment material should be outfitted in modified Level D personal protective equipment, including oil-resistant gloves and safety glasses. Additionally, the report stated that special actions associated with state environmental regulations regarding the handling, storage, disposal or ownership of contaminated sediments (as described in Louisiana Administrative Code Title 33:V) may be required.
