**APPENDIX D**  
**TASK FORCE GUARDIAN DETAILS**

# Lake Pontchartrain, LA and Vicinity Hurricane Protection Project

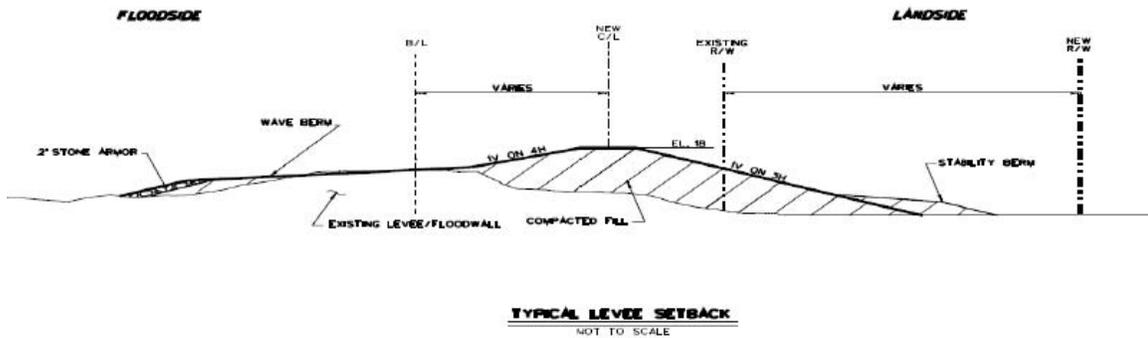
## ***LANDSIDE LEVEE ENLARGEMENTS***

### ***PROPOSED WORK ON DAMAGED NOV FLOODWALLS***

1. Haul, spread, and compact levee embankment material on the landside berm of the existing levee. The enlargement will consist of a 45-ft wide wave berm, a 1V on 4H riverside slope, a 10-ft wide crown at elevation 17 NAVD 88, and 1V on 3H landside slope.
2. The enlargements will replace sections of damaged wall. Remove both capped and uncapped sheetpiles by burning the piles 2 feet below ground surface.
3. Fertilize and seed the freshly compacted embankment.
