APPENDIX E
REGULATORY RECORDS

Final Corrective Action Report
Lincoln Beach, 14001 Hayne Boulevard, New Orleans, LA
LDEQ AI#: 93800

**Re: Lincoln Beach PCB Remediation Completion;
MMG File #: 2120-PCB, 2211-A-CNO**

Corrective Action Plan Report – Lincoln Beach
14001 Hayne Blvd., New Orleans, LA

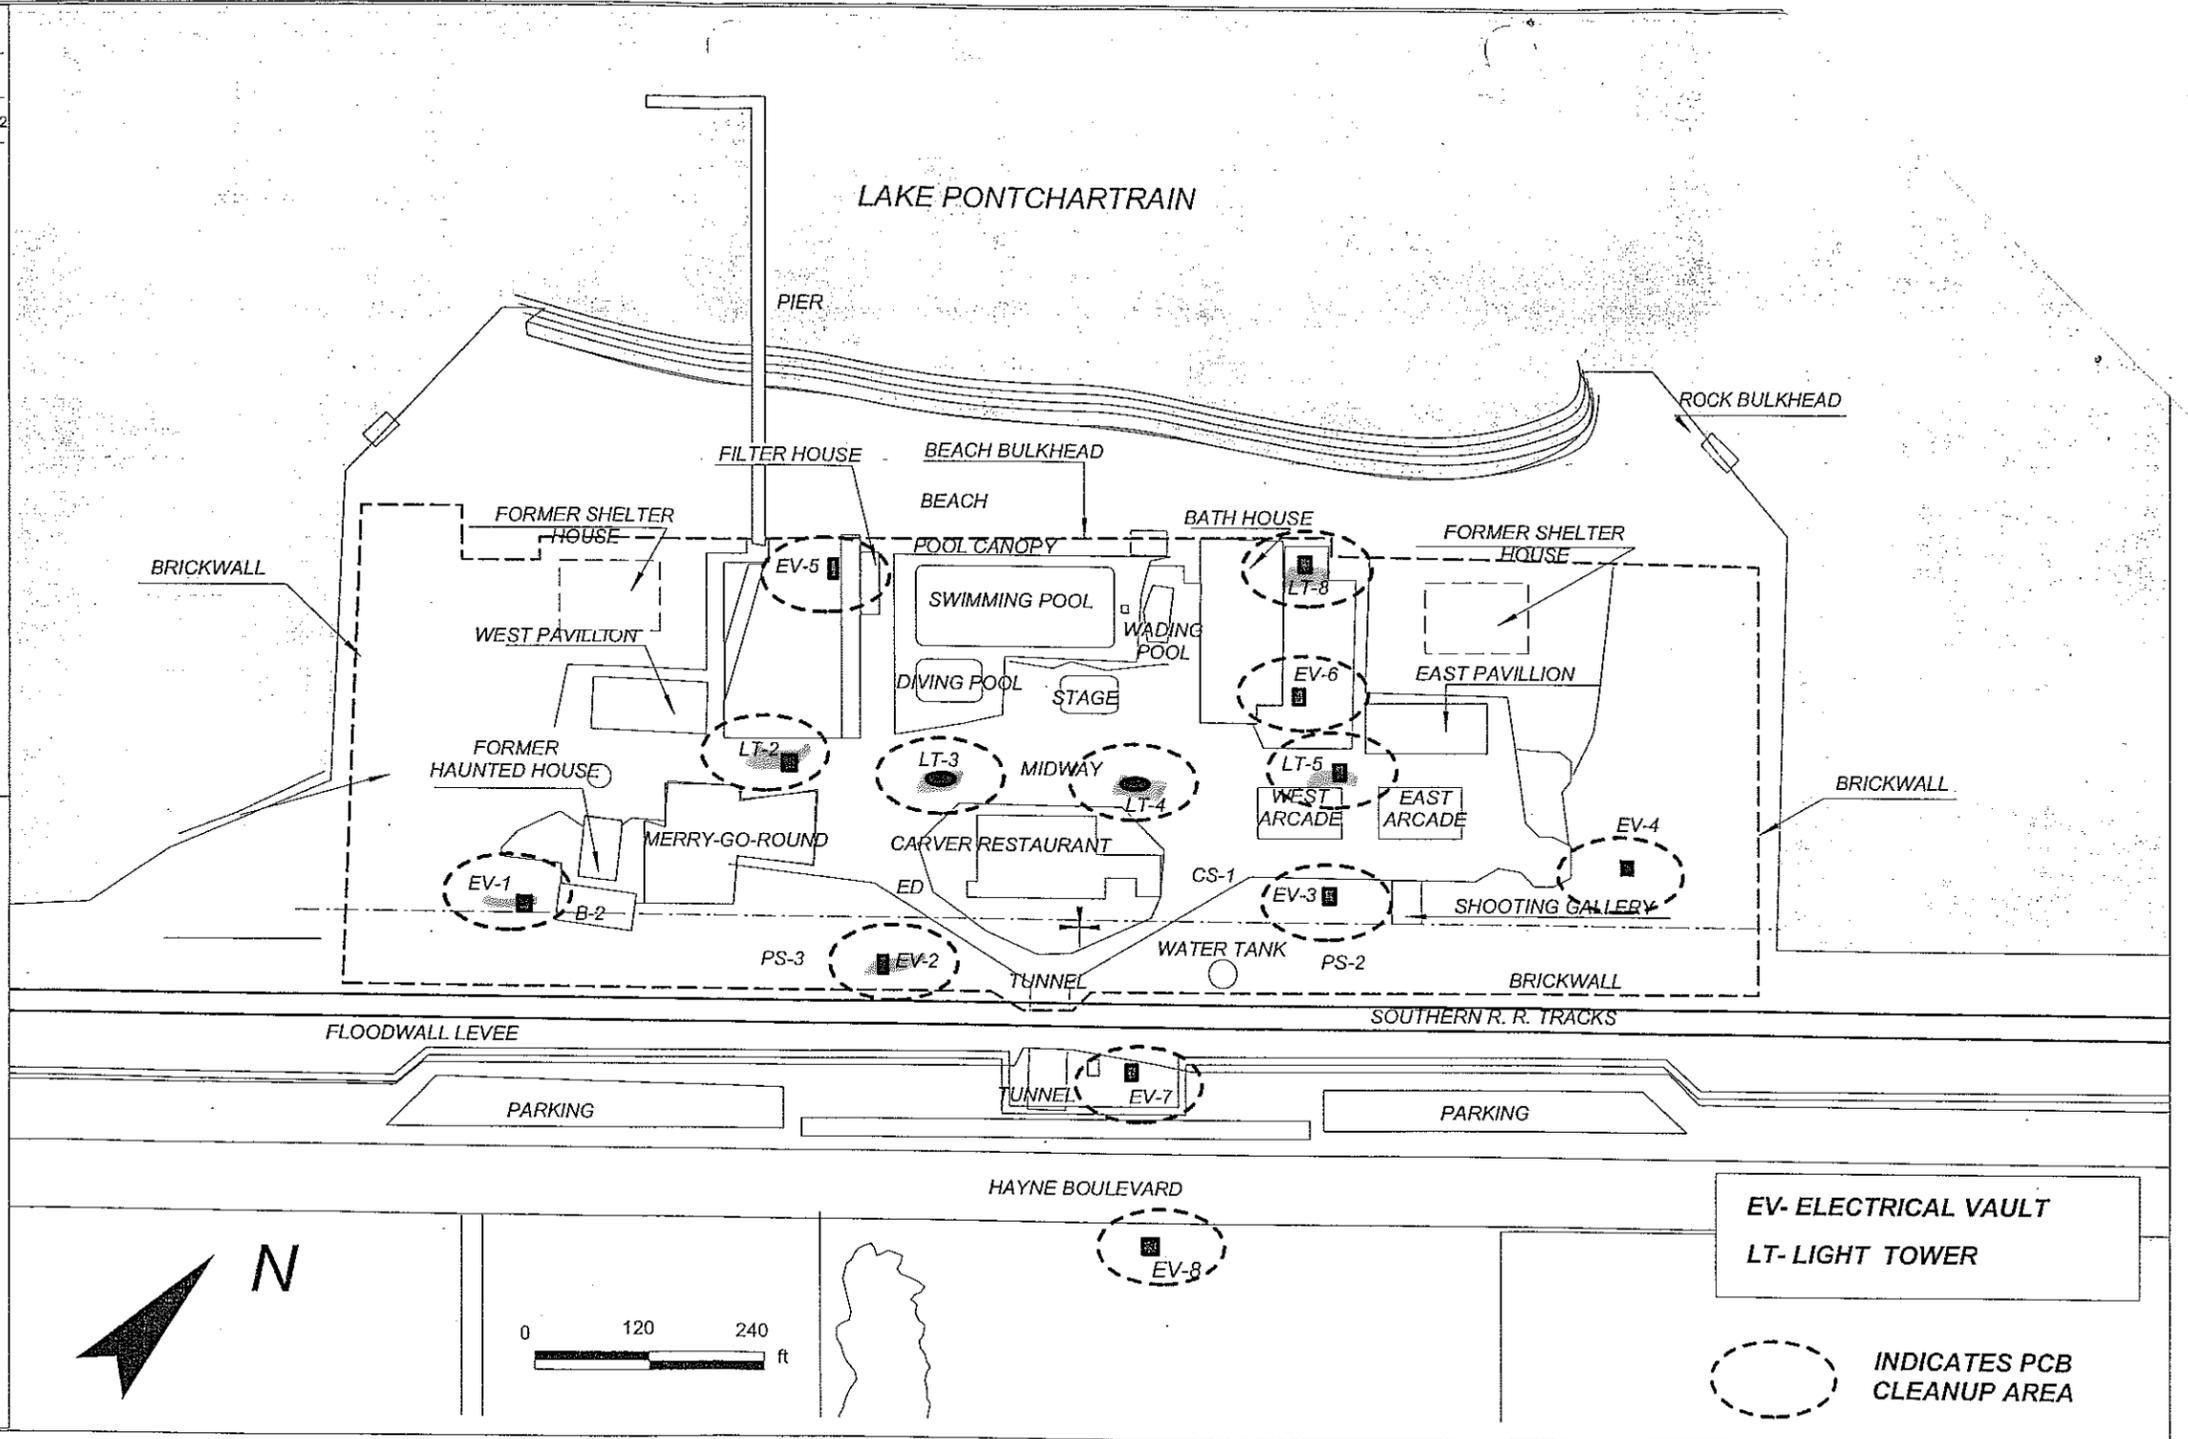
FIGURE 2: SITE MAP

On behalf of the New Orleans Building Corporation (NOBC), Materials Management Group, Inc. (MMG) has implemented the scope of work detailed in the Corrective Action Plan (CAP), dated January 2002, for 14001 Hayne Boulevard, New Orleans, Louisiana (see Figure 1, Site Location Map). The site under investigation is the former Lincoln Beach Amusement Park and parking lot. The park was closed in 1964 and has since not been used. The CAP was developed subsequent to Phase I and II Environmental Site Assessments, a Louisiana Department of Environmental Quality (LDEQ) Risk Evaluation/Corrective Action Program (RECAP) Site Assessment, and later sampling on behalf of the Environmental Protection Agency (EPA) Region 6 conducted at the site. The results of these assessments revealed PCB contamination of concrete slabs within the eight electrical vault buildings at the site, as well as PCB soil contamination at two of the vaults, electrical vault 1 (EV-1) and electrical vault 2 (EV-2), and five of the light towers (LT-2, LT-3, LT-4, LT-5, and LT-8). See Figure 2 for a Site Map.

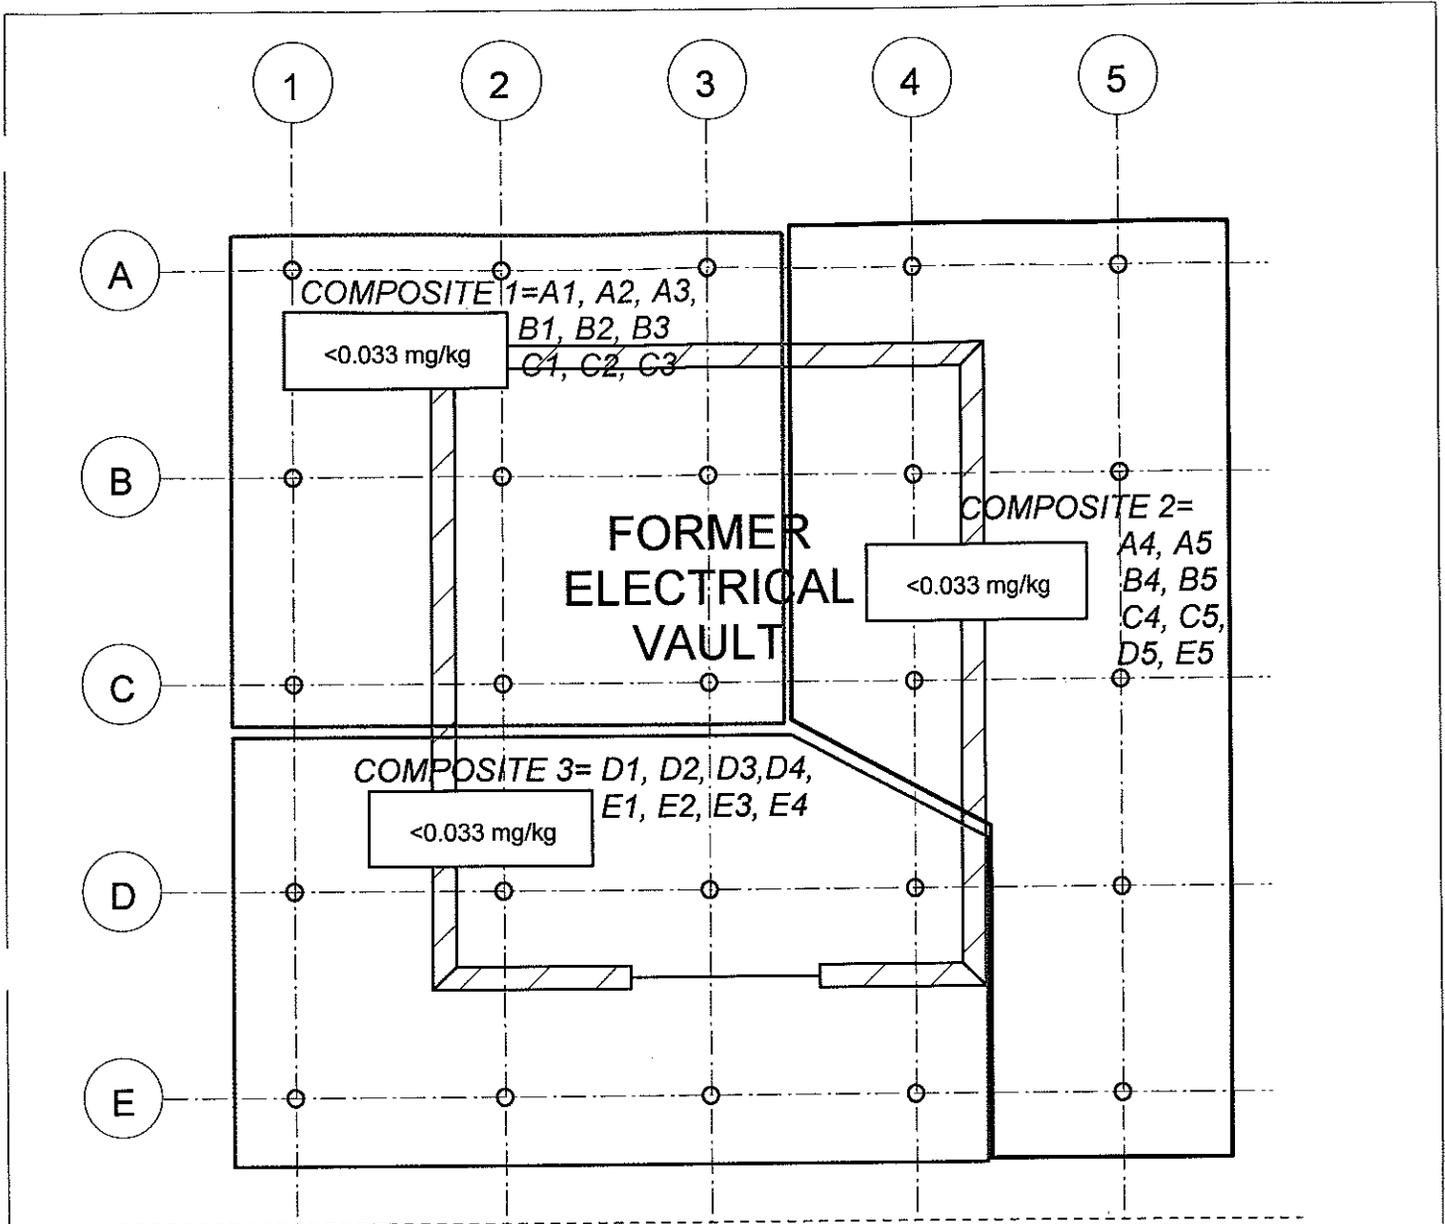
DRAWN: BEN TSAI FILE: 2211-PCB	FIGURE:3c: ELECTRICAL VAULT EV-3 VERIFICATION SAMPLE LOCATIONS	MATERIALS MANAGEMENT GROUP
	LINCOLN BEACH PCB CLEANUP APRIL/ MAY 2003	3520 GENERAL DEGAULLE SUITE 3010 NEW ORLEANS, LOUISIANA 70114 PHONE: 504-368-0568, FAX:368-8403

BKI collected one sample from the 0-2 foot soil interval at two feet from the vault door. The result was non-detect, however, the detection limit failed RECAP. Therefore, MMG included EV-3 in the RECAP Site Assessment. MMG drilled

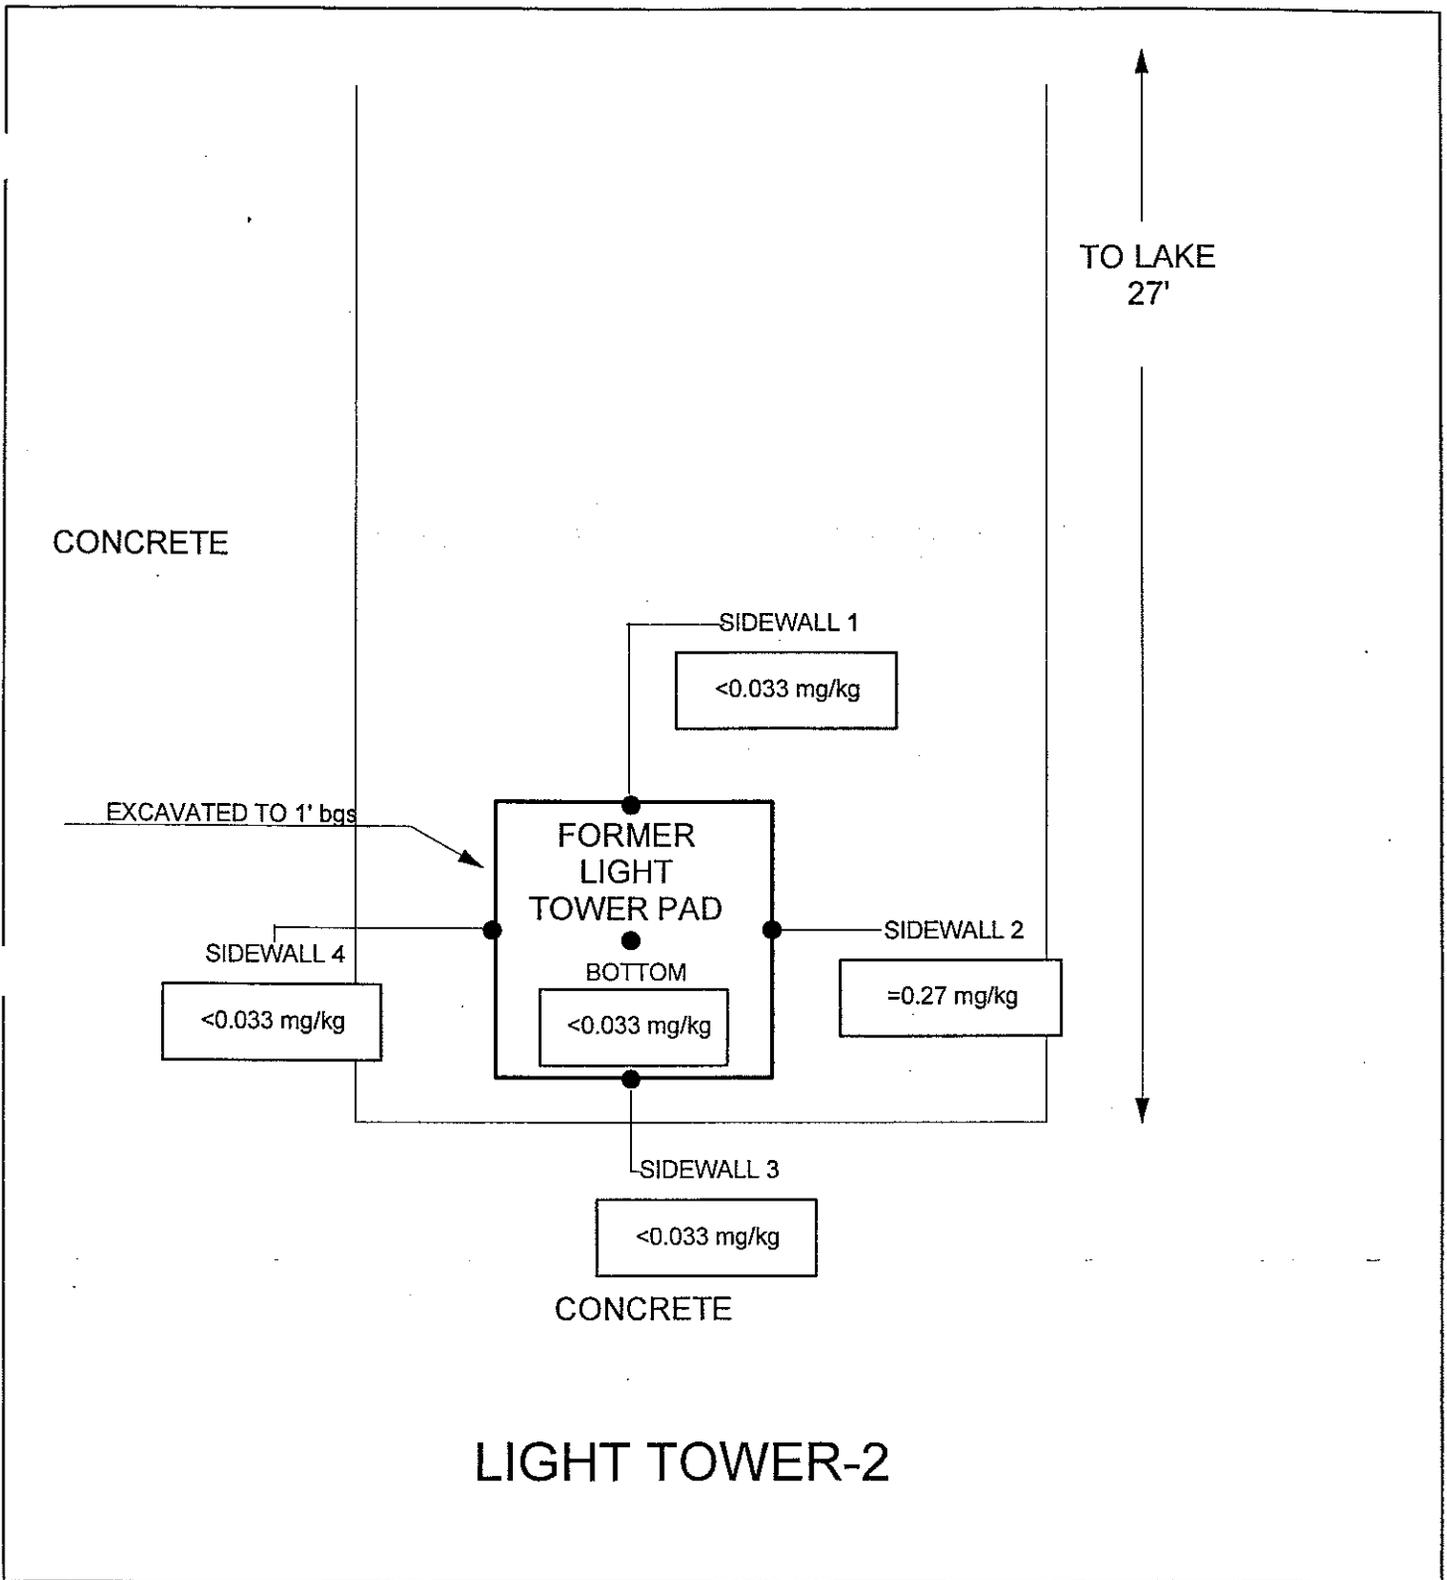
LIGHT TOWER-2

BKI collected one sample from 0-2 feet bgs at the base of the light tower. The result was non-detect (<0.017 mg/kg). MMG did not include light tower 2 in the RECAP Site Assessment. MMG collected two soil samples from 0-6 inches bgs to meet EPA requirements; the results were above the RECAP RSni. During the cleanup, MMG removed the light tower foundation, excavated to one foot bgs, and collected confirmatory soil samples. The results were non-detect except one of the sidewalls (SW2) was above the RECAP RSni. MMG then excavated an additional three feet at SW2 (for a total of four feet bgs) and collected an additional confirmatory sample. The result was non-detect.

BKI also collected a sample of groundwater from the borehole at the base of the light tower. This sample indicated a PCB concentration of 0.0018 mg/l. However, this sample was collected from the borehole and was not filtered. BKI then installed a temporary monitoring well six feet from the borehole (the well could not be installed in the same area due to the light tower foundation). The groundwater sample collected from the monitoring well was non-detect for PCBs. The detected concentration in the previous sample was attributed to suspended solids (PCBs are insoluble and have a tendency for adsorption). Based on the results of this investigation, groundwater at the site is not impacted. The monitoring well was plugged and abandoned.

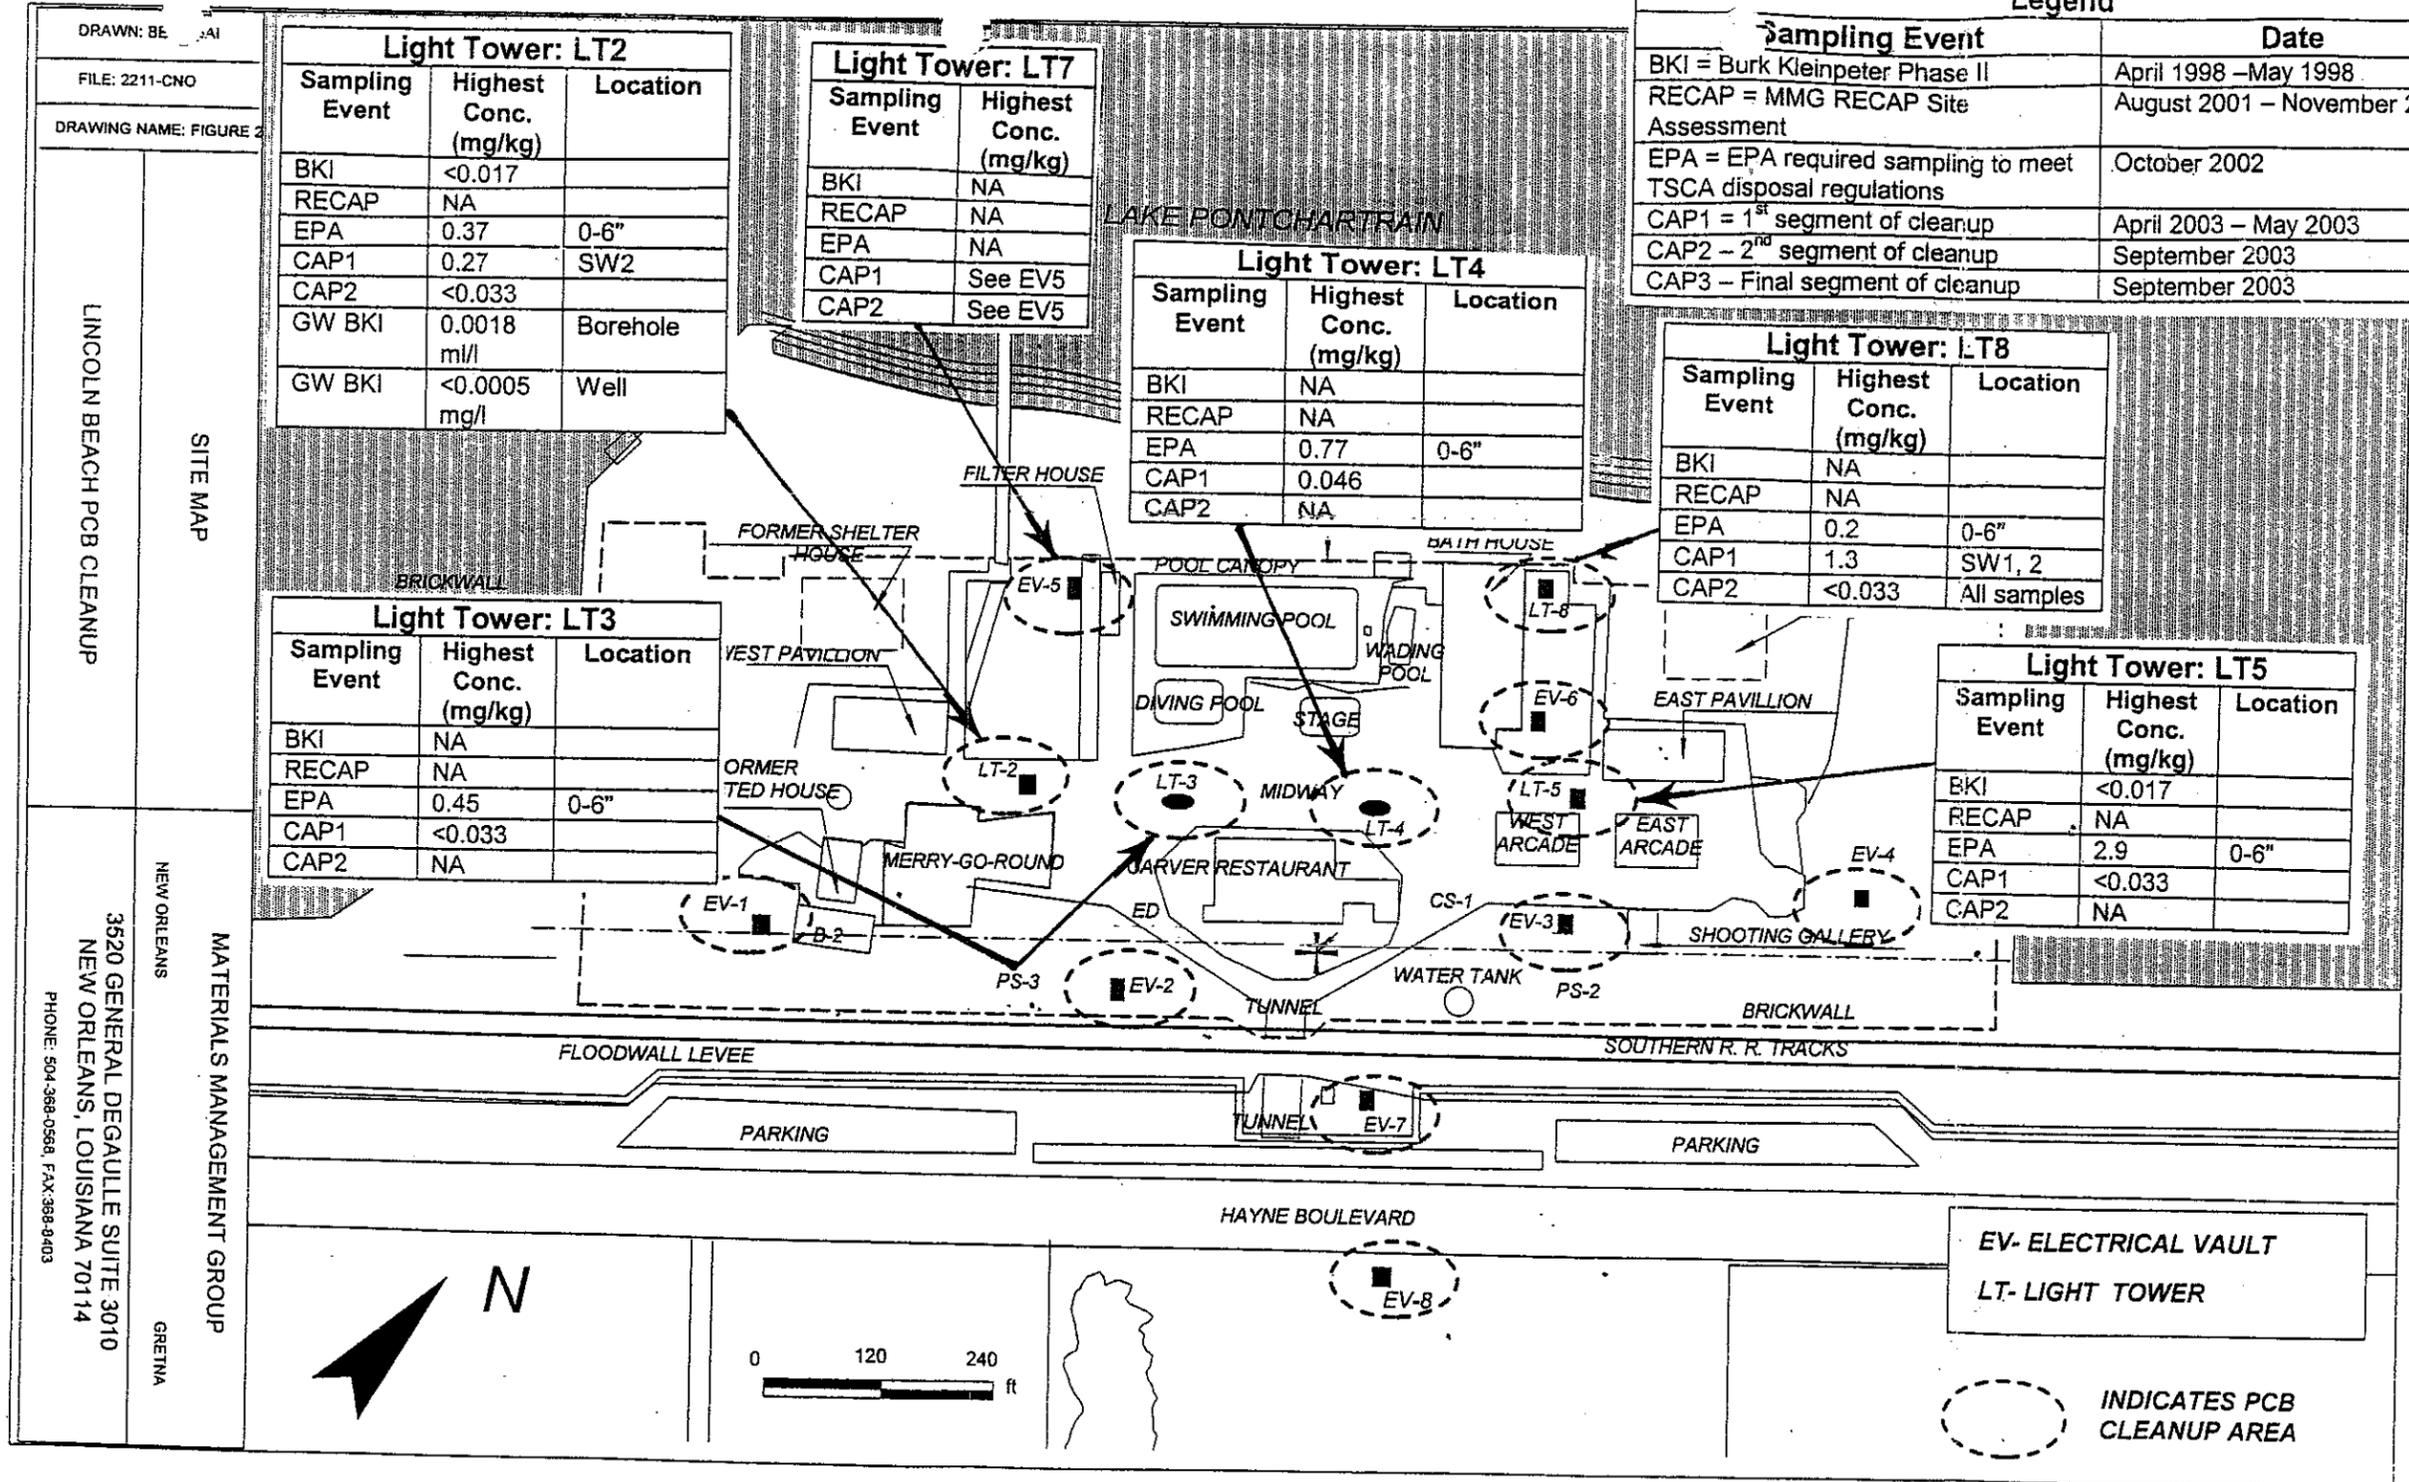
DRAWN: BE [unclear]
 FILE: 2211-CNO
 DRAWING NAME: FIGURE 2
 LINCOLN BEACH PCB CLEANUP
 SITE MAP

Light Tower: LT3		
Sampling Event	Highest Conc. (mg/kg)	Location
BKI	NA	
RECAP	NA	
EPA	0.45	0-6"
CAP1	<0.033	
CAP2	NA

Light Tower: LT5		
Sampling Event	Highest Conc. (mg/kg)	Location
BKI	<0.017	
RECAP	NA	
EPA	2.9	0-6"
CAP1	<0.033	
CAP2	NA

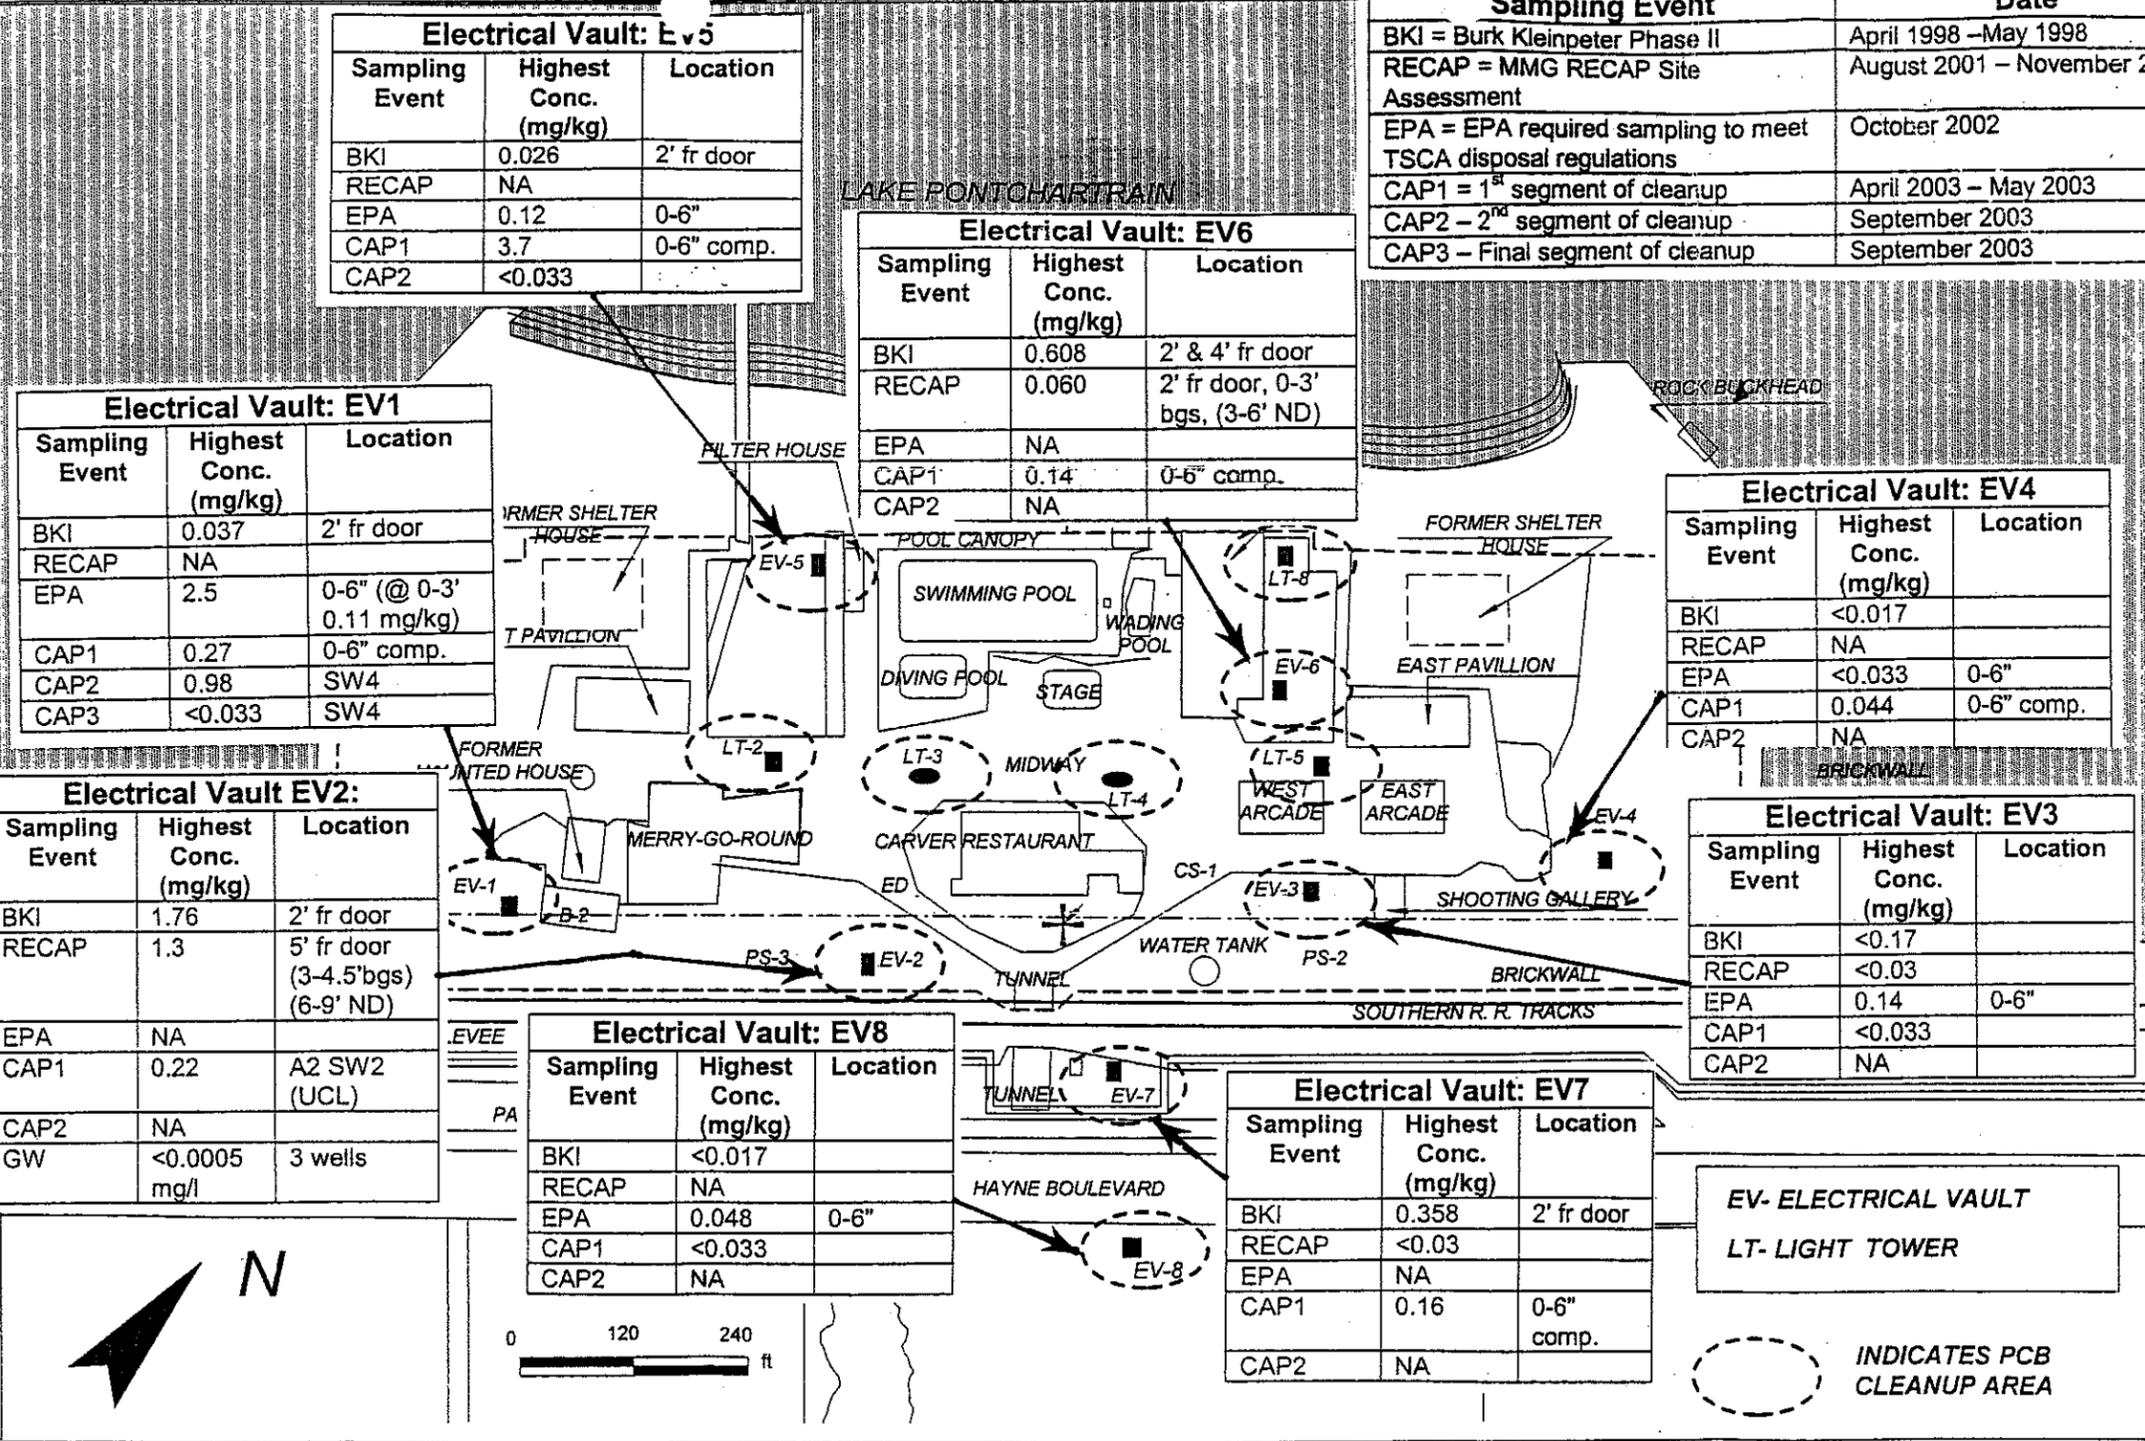
DRAWN: B JAI
 FILE: 2211-CNO
 DRAWING NAME: FIGURE 2
 LINCOLN BEACH PCB CLEANUP
 NEW ORLEANS
 3520 GENERAL DEGAULLE SUITE 3010
 NEW ORLEANS, LOUISIANA 70114
 PHONE: 504-368-0568, FAX: 368-9403
 MATERIALS MANAGEMENT GROUP
 GREINA

Sampling Event	Highest Conc. (mg/kg)	Location
BKI	0.026	2' fr door
RECAP	NA	
EPA	0.12	0-6"
CAP1	3.7	0-6" comp.
CAP2	<0.033

Sampling Event	Highest Conc. (mg/kg)	Location
BKI	0.608	2' & 4' fr door
RECAP	0.060	2' fr door, 0-3' bgs, (3-6' ND)
EPA	NA	
CAP1	0.14	0-6" comp.
CAP2	NA

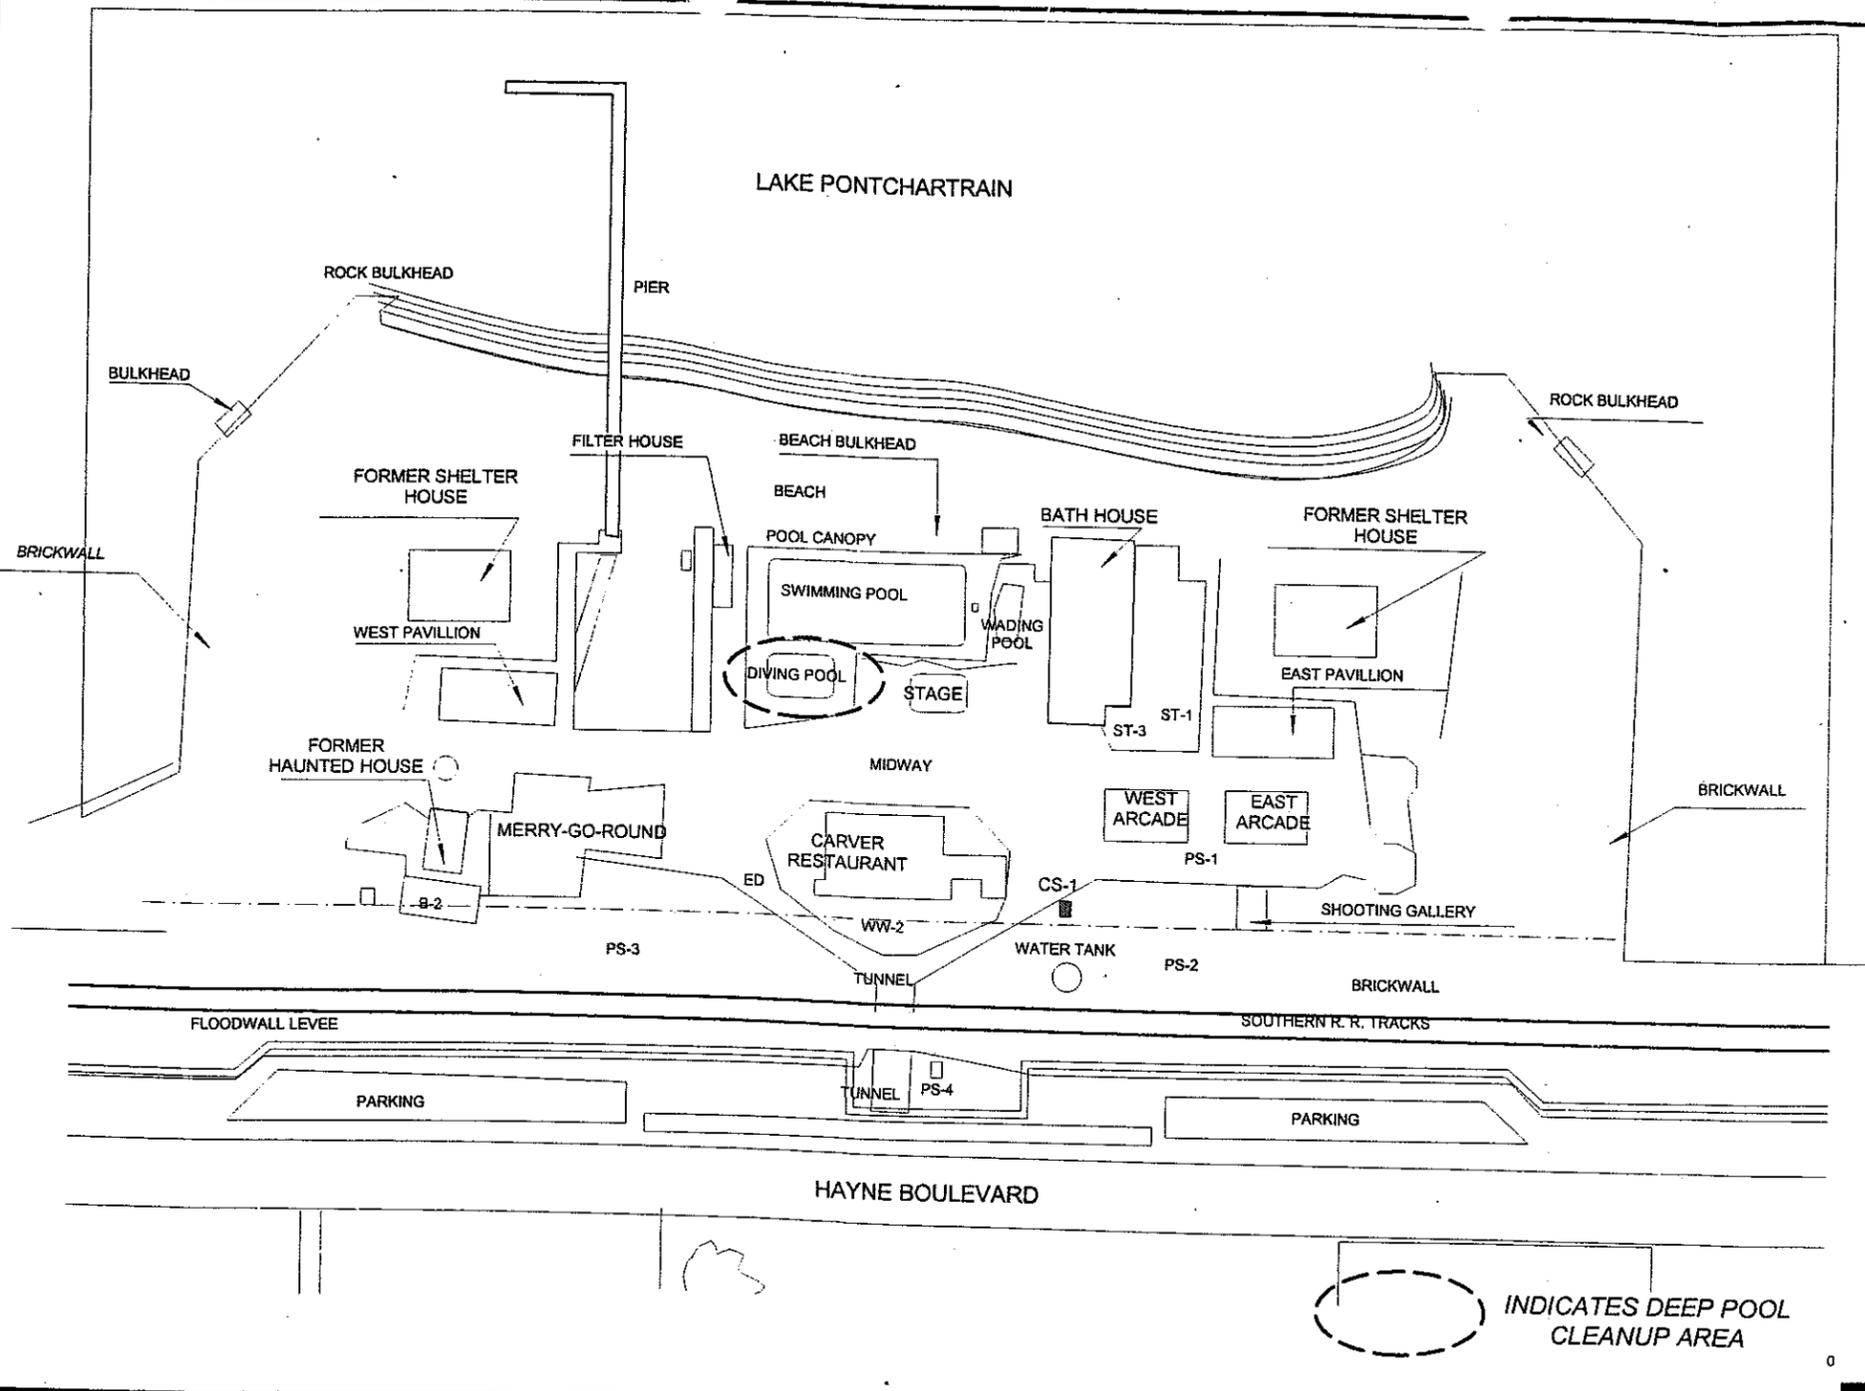
Figure 1: Site Location Map (deep Pool)
 LINCOLN BEACH DEEP POOL FINAL EXCAVATION

Following removal of the concrete, MMG used a trackhoe to excavate two areas (see Figure 1). An area approximately 20 feet by 25 feet was excavated to a minimum of three feet below the surface of the pool bottom to remove any PCB contamination associated with former concrete sample location P2 and P3 (see Figures 2 and 3). An area approximately 15 by 20 feet was excavated to three feet below the surface of the pool bottom to remove any PCB contamination associated with former concrete sample location P5 (see Figures 2 and 3). The excavated soil was placed in roll-off boxes along with the contaminated concrete and sent for disposal at Jefferson Parish Landfill. A total of 157.3 tons of soil and concrete were sent for disposal.

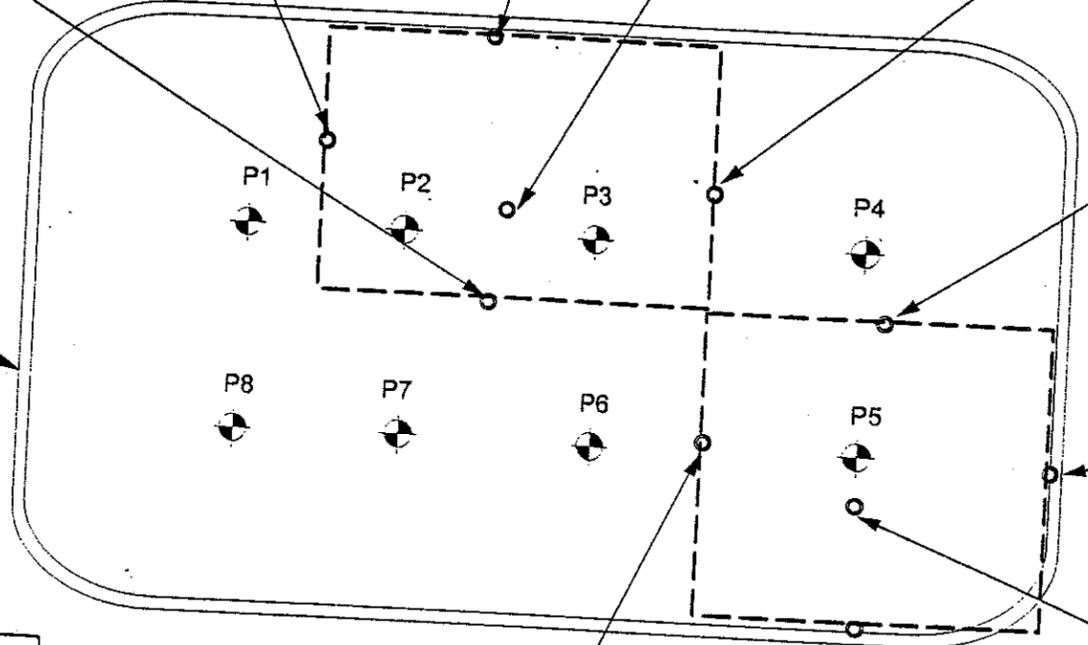
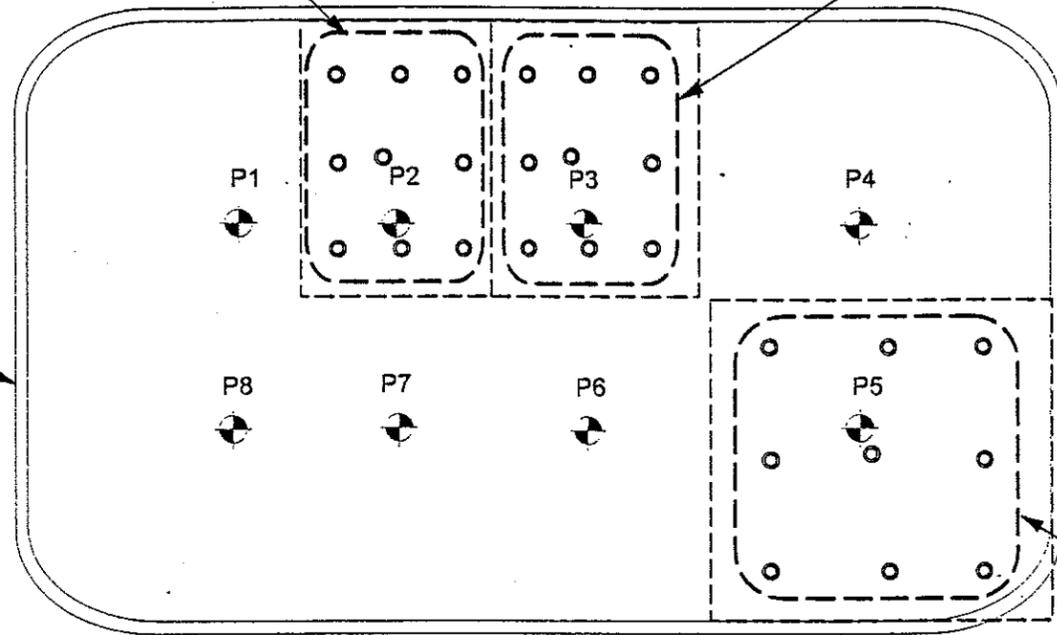
Figure 2: Initial Cleanup Effort-Excavation Limits and LDEQ Confirmatory Sample Locations
 LINCOLN BEACH DEEP POOL INITIAL EXCAVATION

Ten confirmatory soil samples were collected (five from each excavation) following the initial excavation efforts (see Figure 2). The sampling consisted of collecting five discrete samples from each excavation area: one from each sidewall and one from the bottom of the pit. The samples were sent to Southern Petroleum Laboratories, Inc. (SPL) in Scott, LA for analysis for PCBs (EPA SW-846 Method 8082).

CS-2211-CNO-P5-SWW
8 ft 0.042 mg/kg

CS-2211-CNO-P5-SWS
8 ft < 0.033 mg/kg

○ CS-2211-CNO-P3-EPA-COMP-2	
8 ft	0.78 mg/kg

CS-2211-CNO-P5-COMP-3	
8 ft	0.27 mg/kg
